CASE STUDY **PHILIPPINES 2016–2018 / TYPHOON HAIYAN**

KEYWORDS: Shelter repairs, Structural assessment, Capacity-building, Cash and Technical Assistance

PROJECT SUMMARY

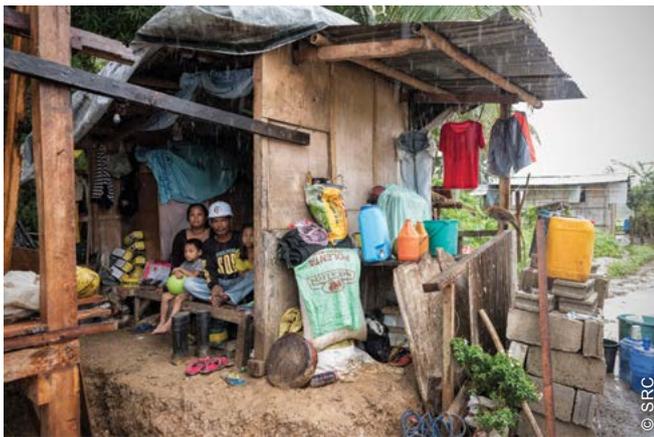
Most houses built in lightweight materials failed during the typhoon and were quickly repaired to be re-inhabited by the affected households.

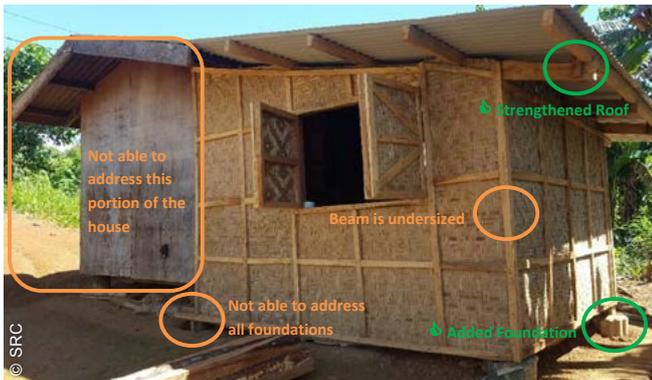
The partner evaluated all the houses repaired through the project, confirming that all had been strengthened after the intervention.

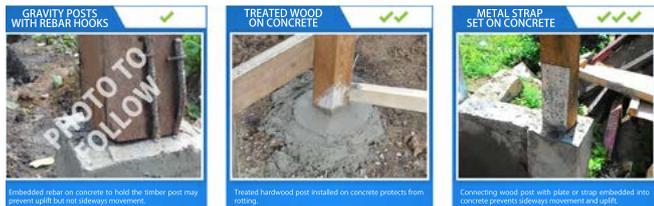
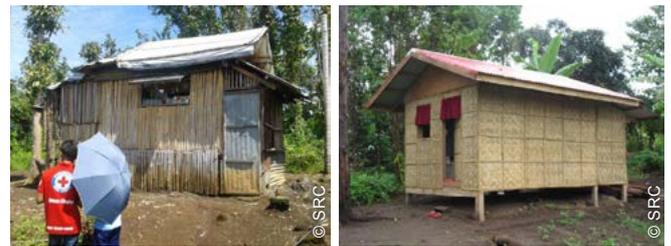
This picture shows a house before and after the intervention. All targeted shelters were structurally strengthened, with a high involvement of the affected people.
