A.6 Mozambique- 2007- Cyclone

Shelter material packages and training

Cyclone Favio in northern Inhambane, Mozambique,
February 2007

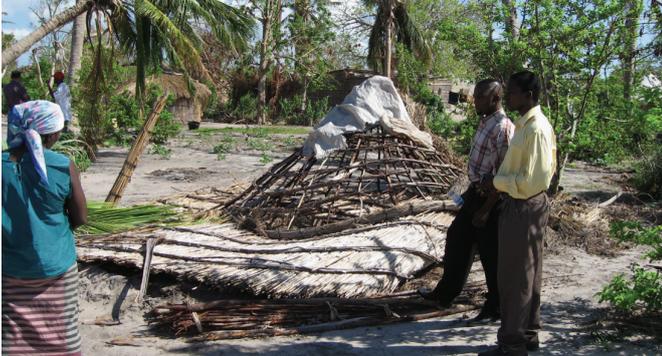
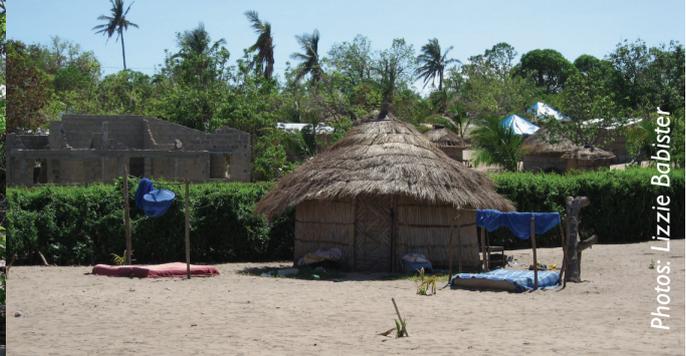
A damaged house and self-built reconstructed house using distributed items
