A.3 Grenada - 2004 - Hurricanes Ivan and Emily

Grenada

Hurricane Ivan (Cat. 4)
& Hurricane Emily (Cat. 1)

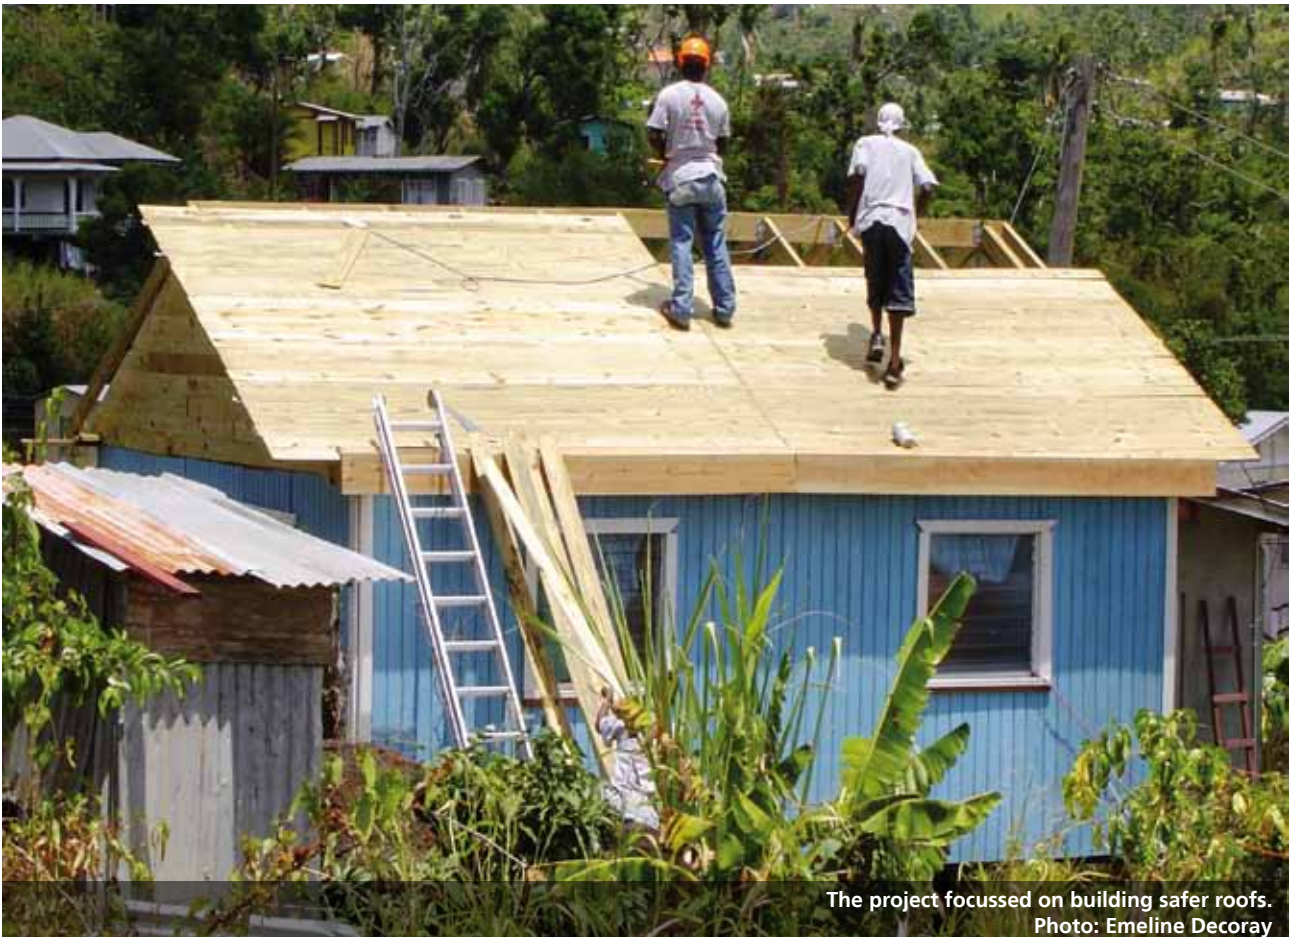
The project focussed on building safer roofs.
Photo: Emeline Decoray

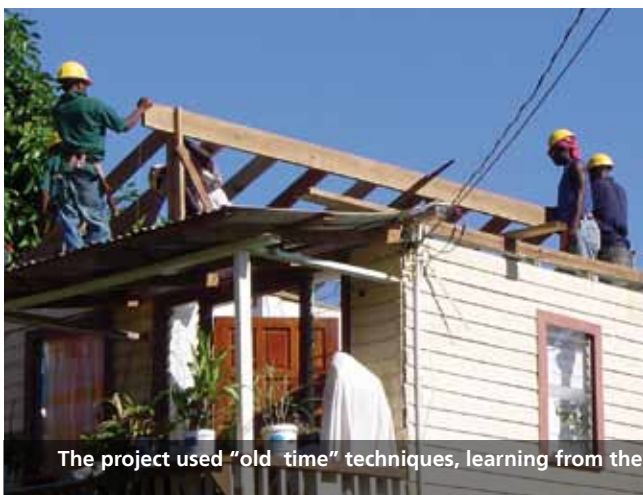
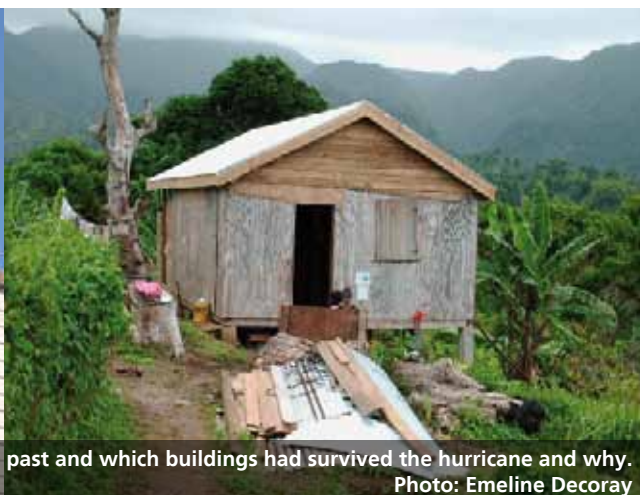
The project used "old time" techniques, learning from the past and which buildings had survived the hurricane and why. Photo: Emeline Decoray

The techniques applied to rebuild the roof and to strengthen the house before building the roof were "old time" techniques, which had resisted Hurricane Ivan. The "old time" wooden houses resisted the wind forces better than the newly built houses, even concrete houses.

The houses received some reinforcement, such as doubling studs in the corners, around doors and windows, bracing the corners in both directions, attaching the flooring beams to the pillars, and attaching them to the foundations with metal straps. The smallest houses received a gable roof with a 30° slope and 25cm eaves, while the largest one received a hip roof.

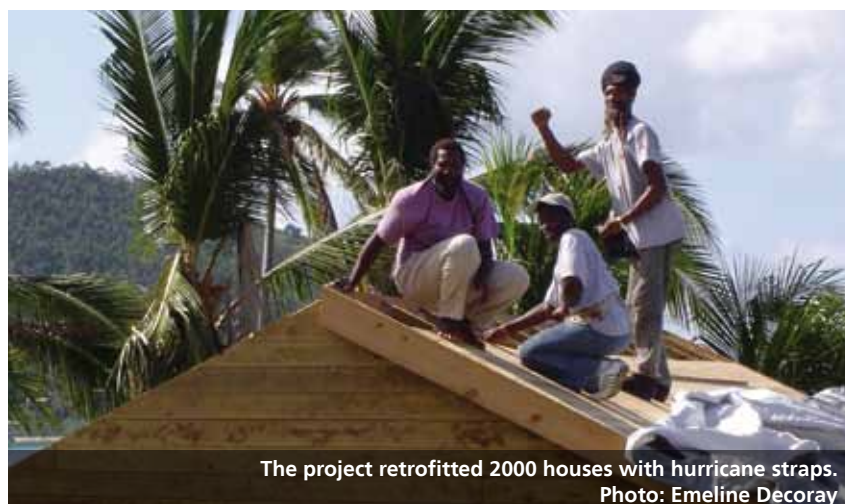
The project retrofitted 2000 houses with hurricane straps. Photo: Emeline Decoray

A disaster preparedness project was also implemented in 32 communities. On weekends, some public awareness activities were held to train some community members on different topics including rebuilding better roofs. As a mitigation project, 2000 vulnerable homes received hurricane straps which were installed by trained community members.
