The following is an excerpt from the Book [Transitional Shelters: 8 Designs, IFRC, 2012](#), available from www.sheltercasestudies.org. [Inclusion of this design is for information purposes and does not necessarily imply best practice](#). Designs are site specific.

B.7 Indonesia, Aceh (2005) - Steel frame

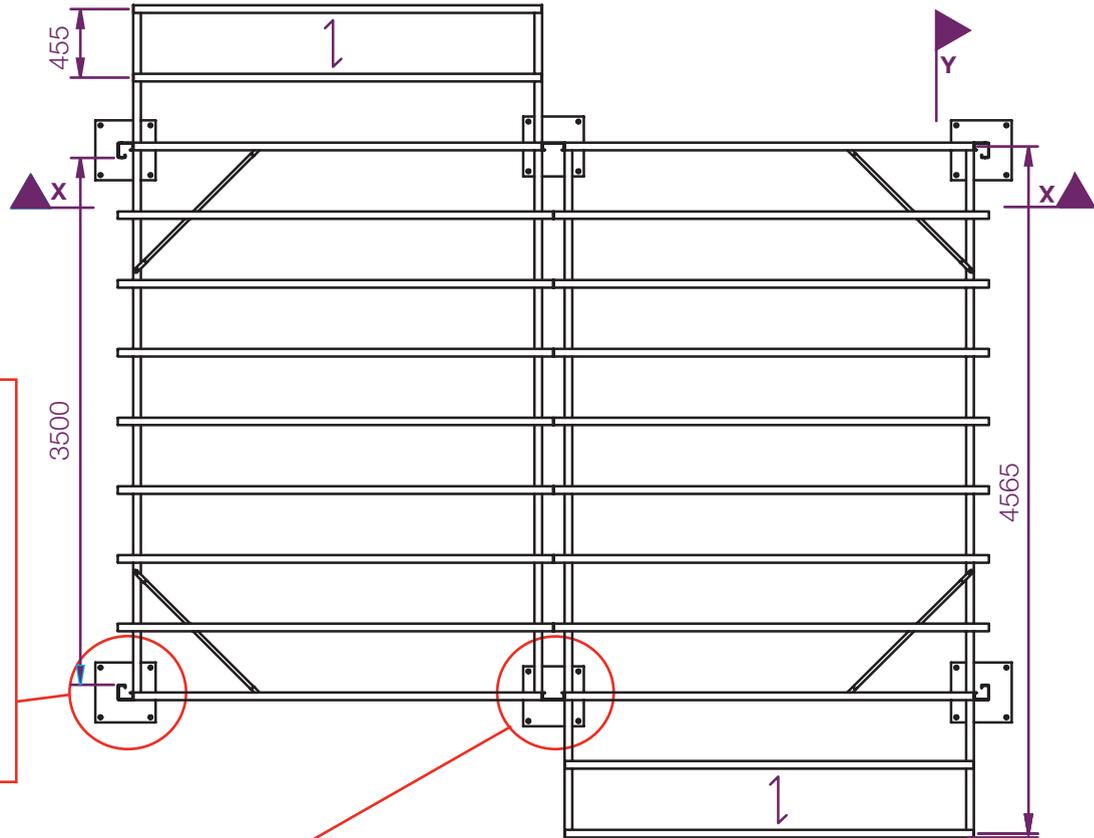
Ground floor plan

CHECK: In areas known to have high local wind pressures adequate foundations and member sizes must be provided.

CHANGE : Modify the foundations from base plate nailed to the soil to concrete pad foundation ([Section C.2](#)) depending on soil type to prevent settlement of shelter.

CHANGE: Use base plate or foundations or screw in ground anchor ([Section C.2](#)) to increase uplift and sliding resistance depending on soil type and wind loads.

CHANGE: All column sizes should be increased in accordance with design to local wind pressures.

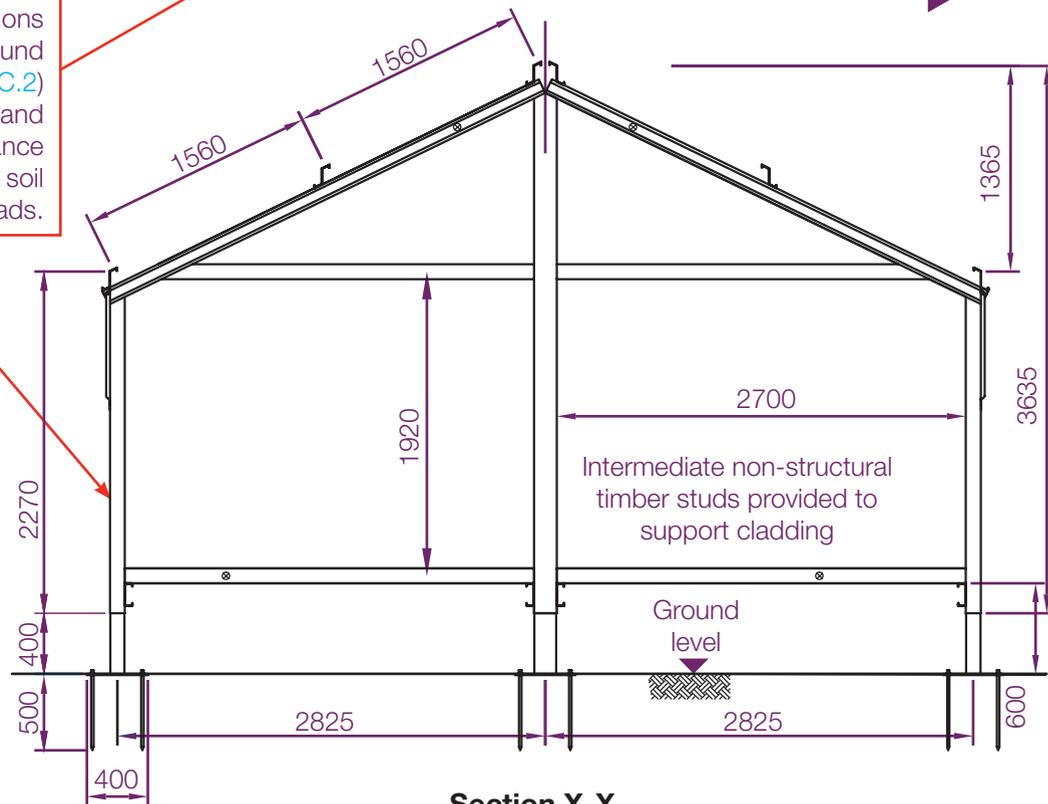
Section X-X

CHECK: The design and detailing of all connections is critical to the stability of the structure and should be checked for individual cases.

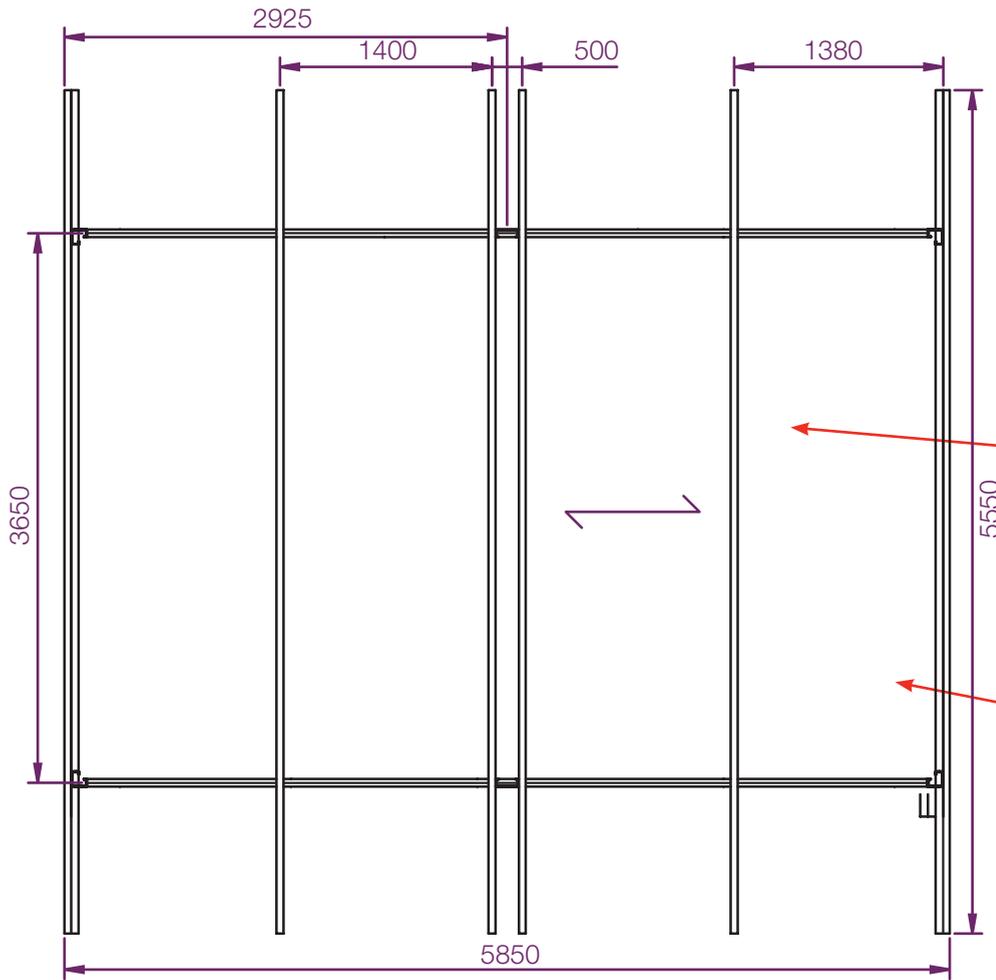
Roof Level Plan

CHECK: Fasten roof sheet to purlins using screws spaced at appropriate intervals (Section C.4).

CHANGE: Provide in-plane bracing in the roof to increase lateral stability.

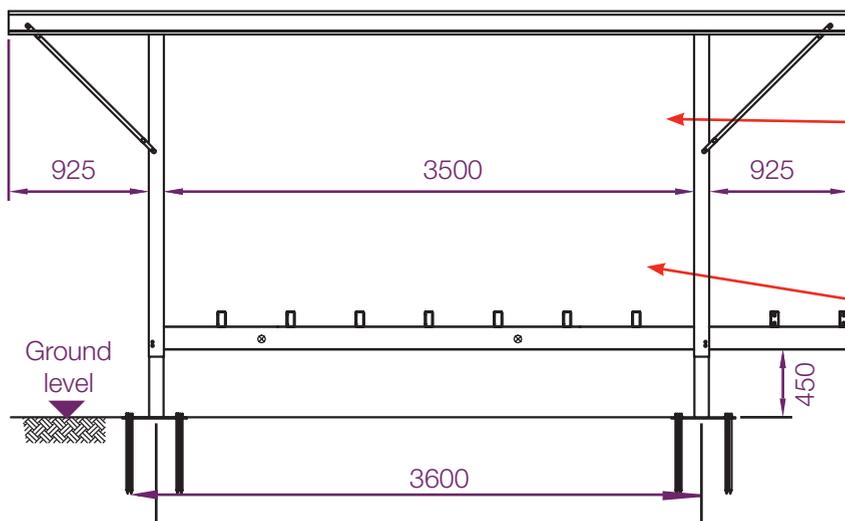
Section Y-Y

CHECK: Do not upgrade walls using masonry or cement blocks due to risk to life and increase in seismic force attracted to the structure.

CHANGE: Improve lateral stability by nailing planks to each other (Section C.3.2) upgrading the walls using 1/2" thick plywood (plywood 1 annex I.1.3) with vertical framing spaced at 600mm and the plywood with maximum 150mm on centre nail spacing (Section C.3). In this case header and primary floor beams would also require strengthening. Alternatively, walls could be braced in-plane with diagonal steel bracing.
