## A.3 Kenya - 2007- Flooding

### Shelter and disaster mitigation

Construction of self-build new shelters for refugees  
Community mobilisation, disaster mitigation

Ifo refugee camp flood response, Dadaab, Kenya, 2007

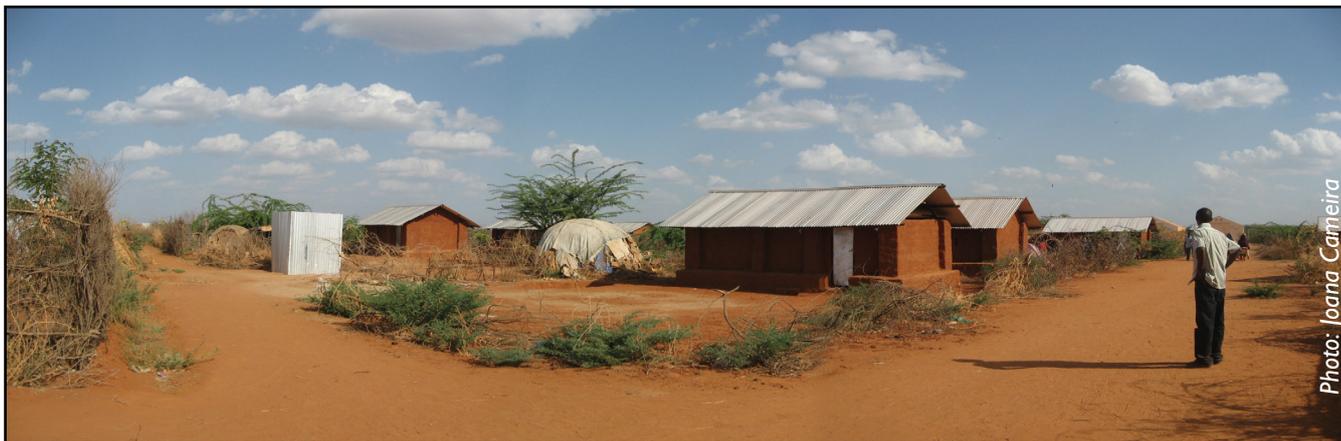
Photo: Joana Cameira

Village constructed through community-based project

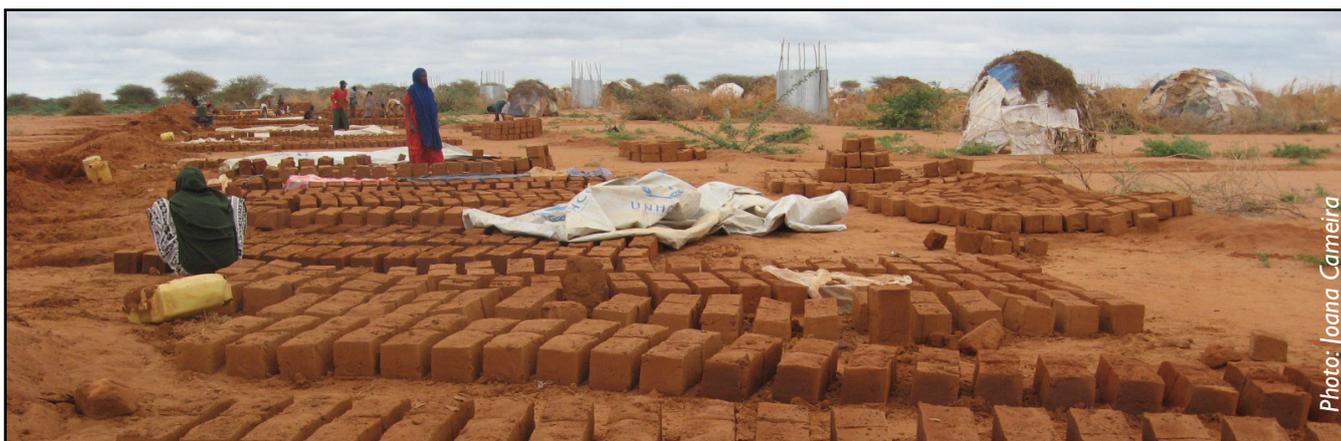
Photo: Joana Cameira

Brick production

A public demonstration of 'brick throwing' to test the strength of bricks made from different soils ignited the interest of potential beneficiaries and addressed the fears of mud-brick houses being weak. The agency constructed some prototype shelters that were then used as classrooms for the construction trainees.

Soil-sourcing sites, both within and outside of the camp, were identified by the agency, which also supplied brick moulds, pangas (knives), wheelbarrows and plastic sheeting to cover completed bricks during the rain. Tools were shared among the community groups and returned to the agency when not in use. Water storage was provided near the soil-sourcing sites.
