## A.22 Pakistan - 2010 - Floods - Overview

## A.23 Pakistan - 2010 - Floods

## A.24 Pakistan - 2010 - Floods

## A.25 Pakistan - 2010 - Floods

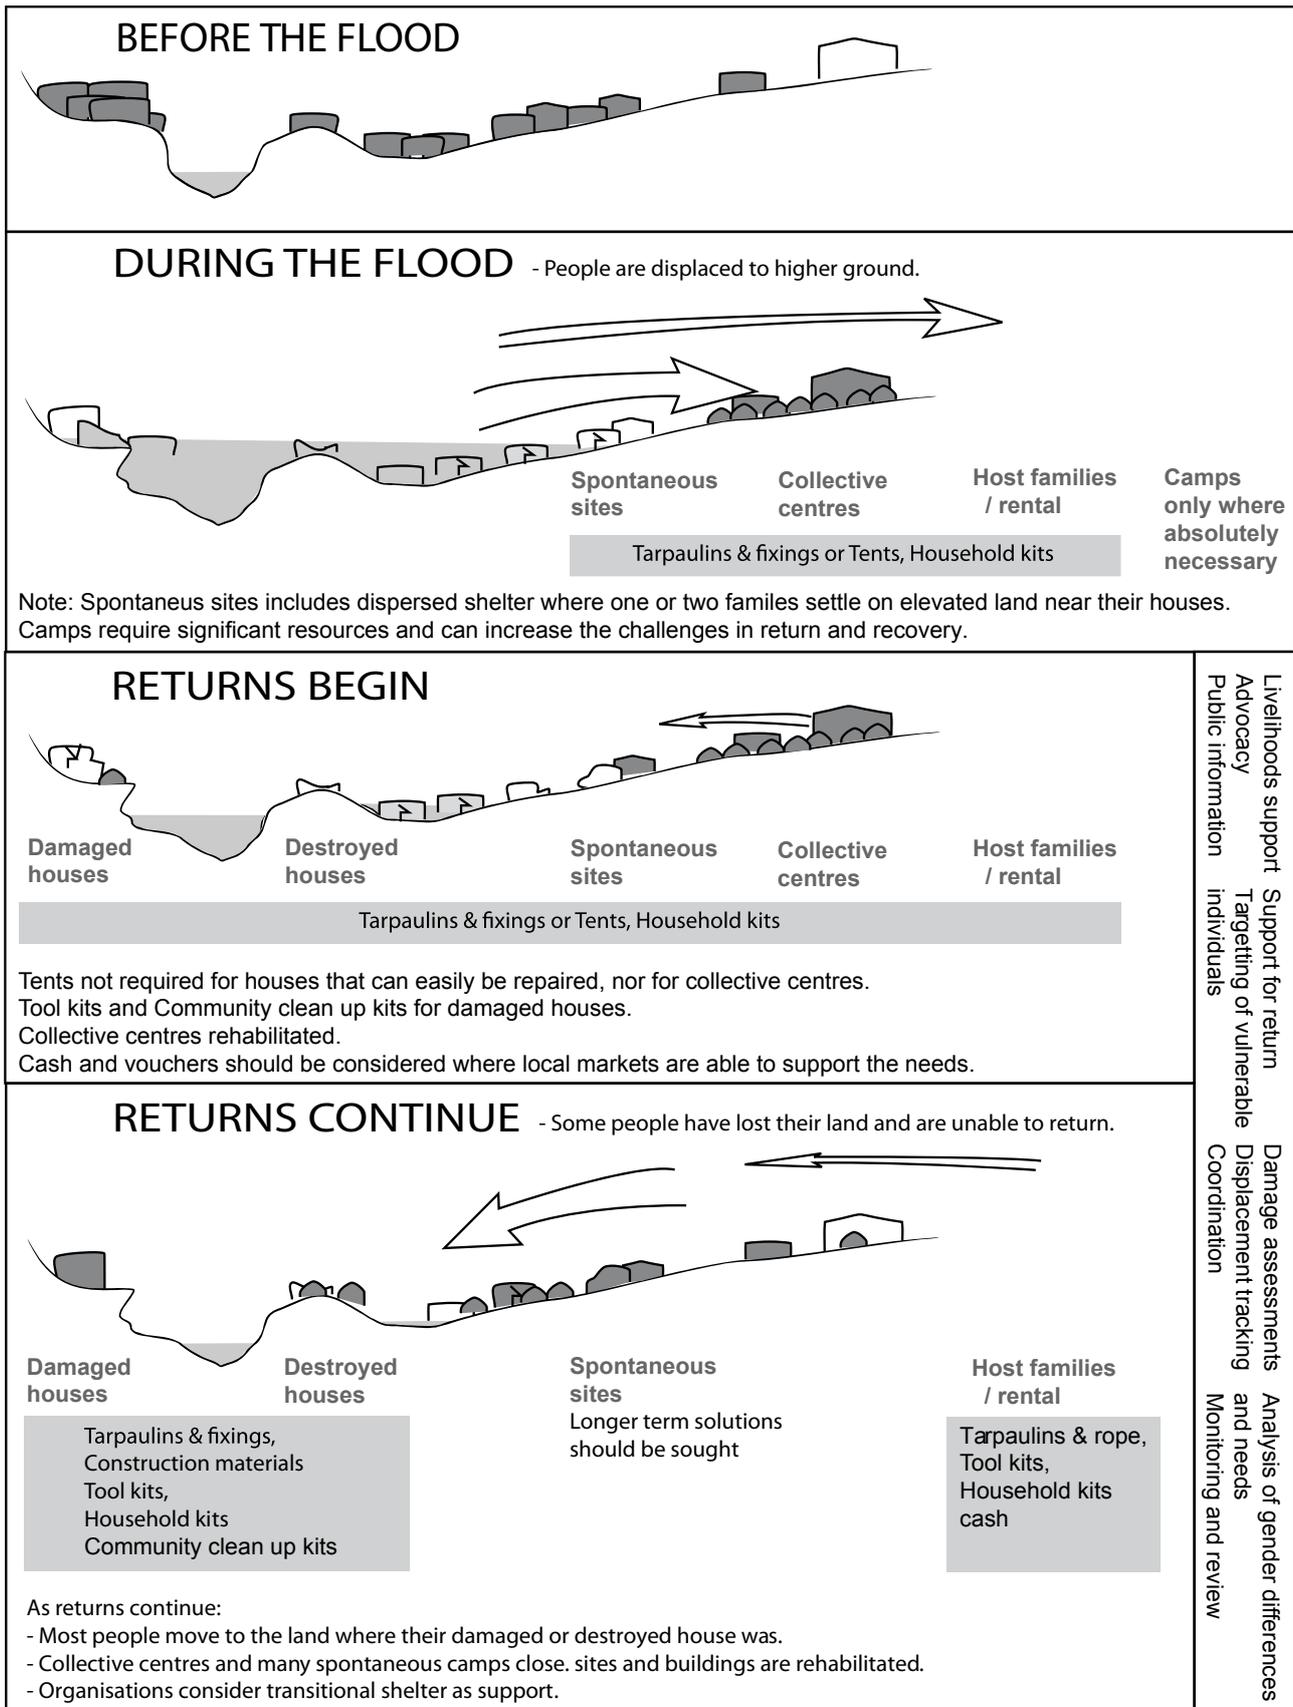
An illustrated version of the initial Shelter Strategy for Pakistan floods - 20th Aug 2010

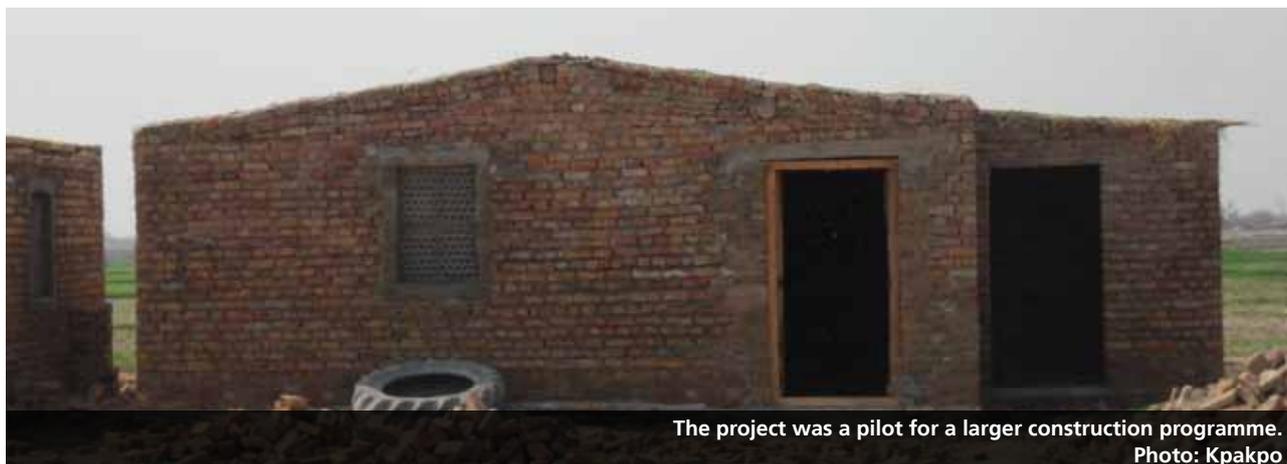
The project was a pilot for a larger construction programme.  
Photo: Kpakpo

This pilot project built 175 one room shelters for flood affected families in South Pakistan. It was later followed by a much larger scale project (building thousands of shelters over 18 months). Working through partners, the agency provided the construction materials and paid for skilled labour. Each shelter was built from burnt brick and had an accompanying kitchen and latrine.

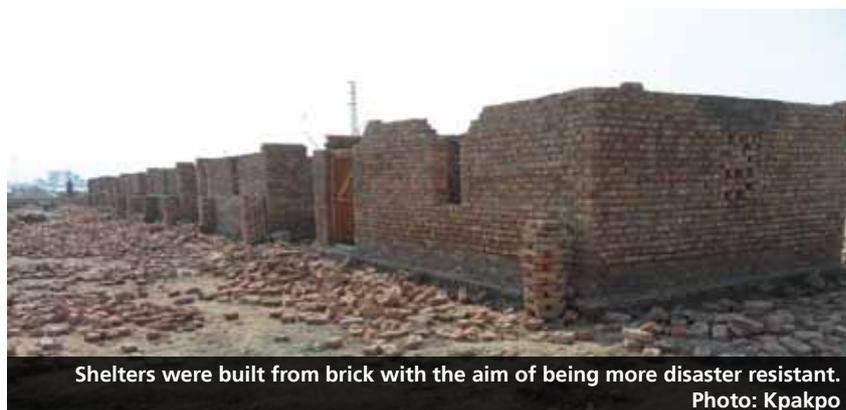
Shelters were built from brick with the aim of being more disaster resistant.  
Photo: Kpakpo

During the procurement, material specifications only indicated the dimensions of the products and as a result, the quality of material varied. Furthermore there was lack of clarity over who was responsible for the materials once they had arrived on site. As a result, a lot of bricks and roofing materials were damaged during off-loading and moving.

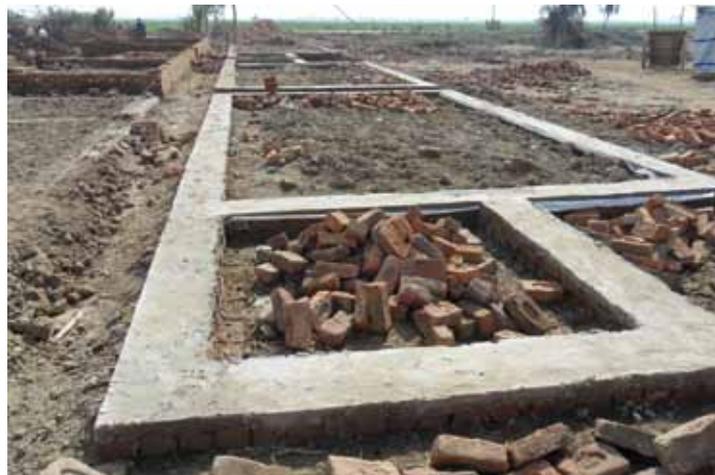
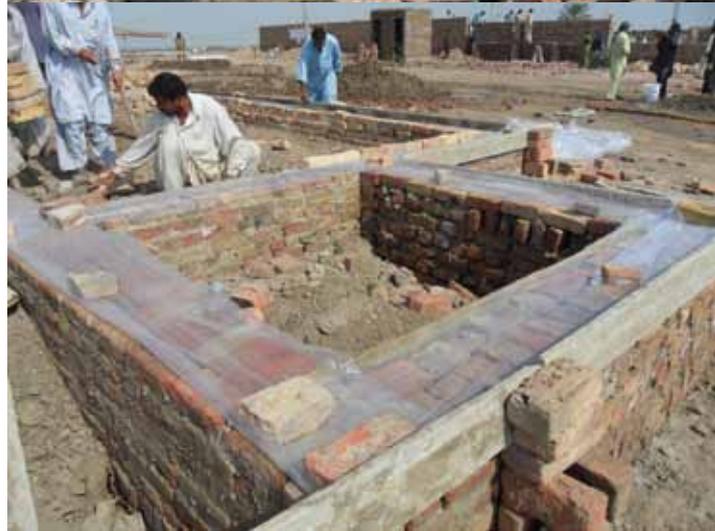
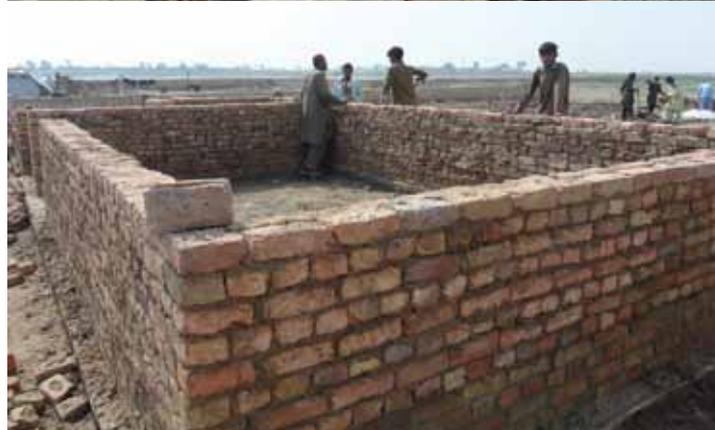
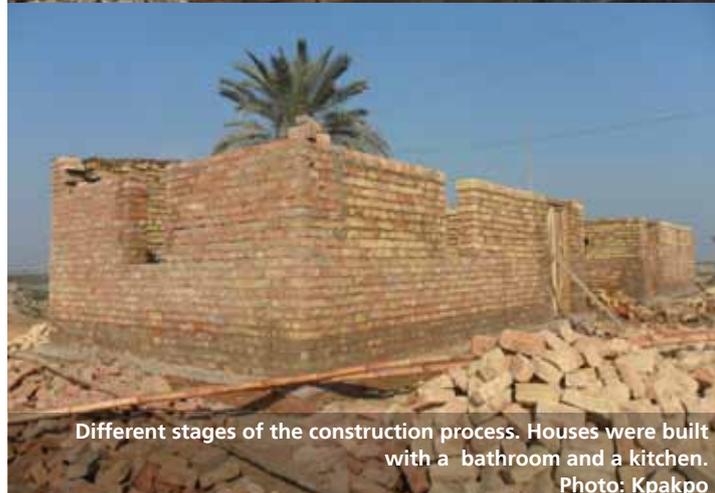
Different stages of the construction process. Houses were built with a bathroom and a kitchen.  
Photo: Kpakpo

Materials	Quantity
Excavation	8m <sup>3</sup>
Foundation: 3% cement & soil mixture	4.6m <sup>3</sup>
Brick masonry (Plinth) 1:4	4.6m <sup>3</sup>
Damp proof course	0.52m <sup>3</sup>
Brick masonry (Wall) 1:4	16.13m <sup>3</sup>
Lintel (reinforced concrete)	1.7m (long)
Wooden girder (roof)	12.3m
Bamboo	83.4m
Mat (2.4m x 6m)	3
Plastic sheet 6mx4m	1.5
20mm thick mud plastering	32m <sup>2</sup>
Door (wooden)	1
Woven mats	12

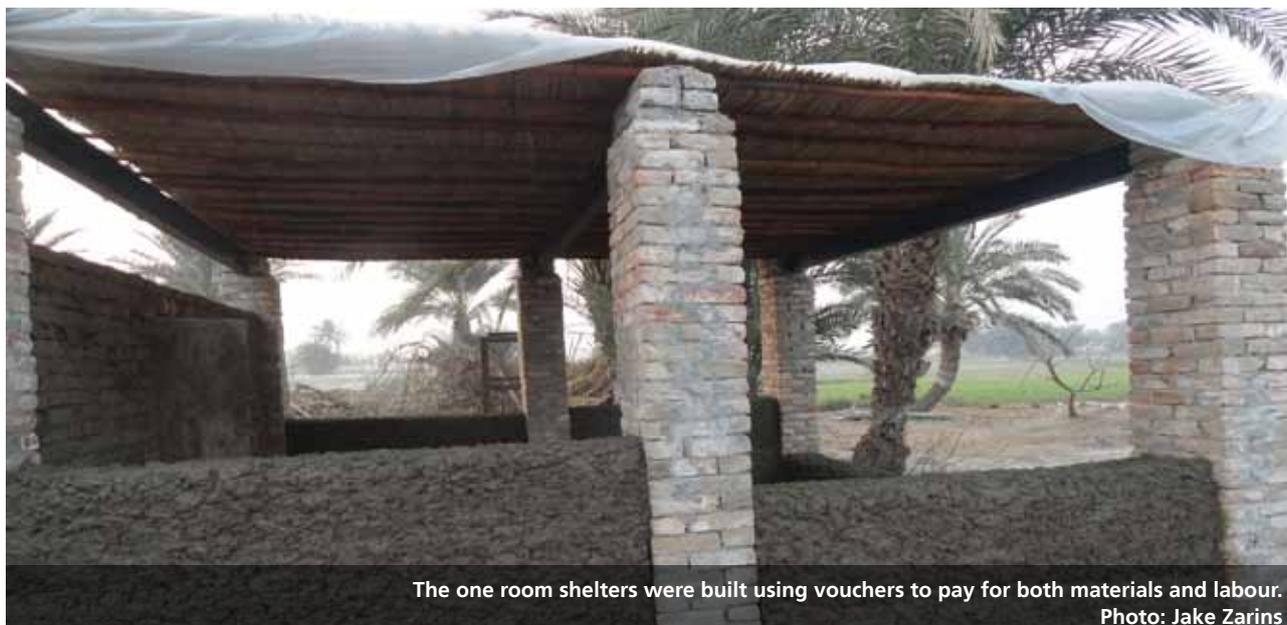
The one room shelters were built using vouchers to pay for both materials and labour.  
Photo: Jake Zarins

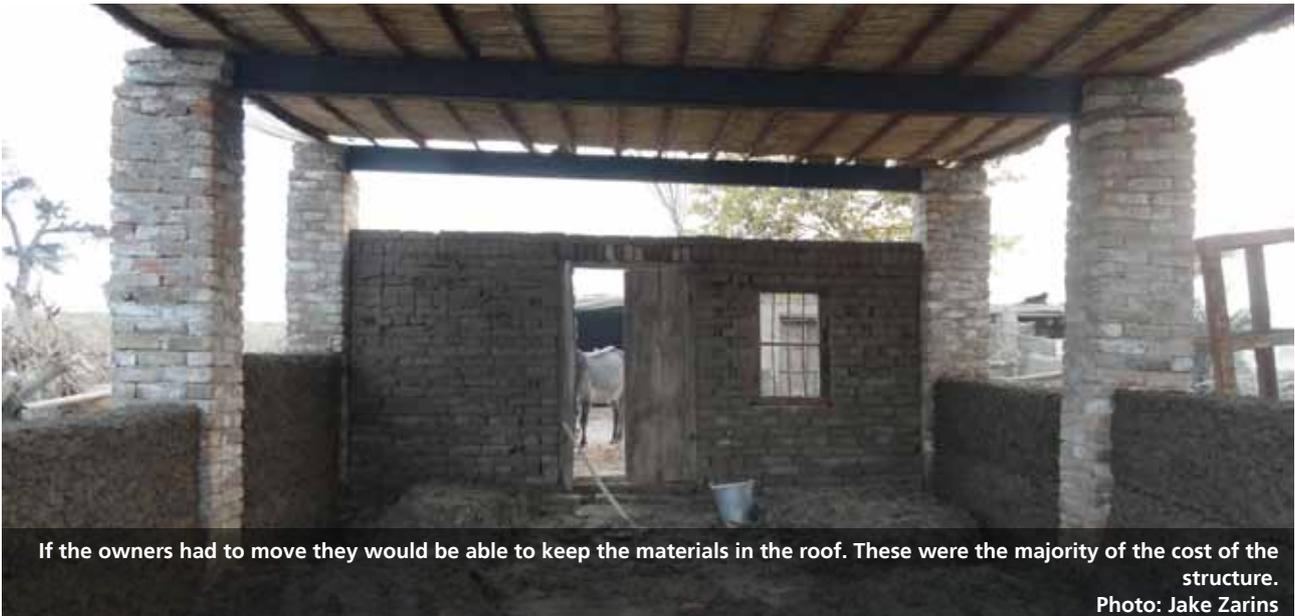
If the owners had to move they would be able to keep the materials in the roof. These were the majority of the cost of the structure.  
Photo: Jake Zarins

The design was based upon brick and cement mortar columns. Each column was built on an individual foundation. These columns were aligned to support 3 steel girders and a traditional style flat roof of bamboo, reeds (*Khick*), plastic sheet and mud plaster.
