A.31 Natural disaster

A.31 Vietnam - 2009 - Typhoons Ketsana and Mirinae

Typhoon Ketsana and Typhoon Mirinae

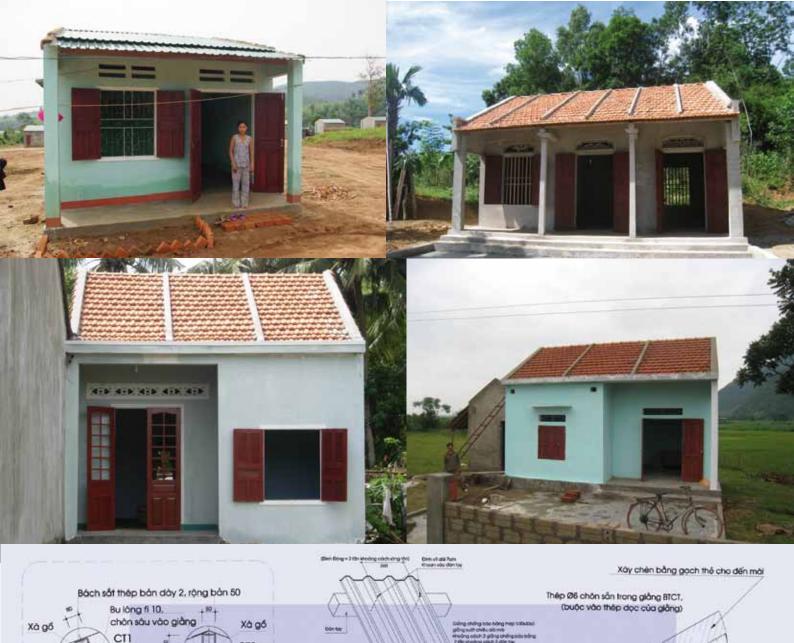
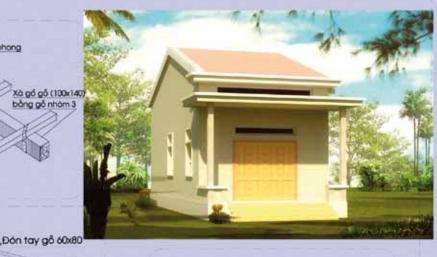
Định ácm neo giữ cấu phong vào xà gố của nhà

Cấu phong gỗ (40x60) bằng gỗ nhóm 3

Bật sắt bằng tôn dây 2 ly (300x20x2) neo cấu phong vào xả gố

CHI TIẾT BỞ CHẢY BỞ TÈ

The project allowed families to adapt basic models of shelter to suit their needs (top). It also provided technical guidance on safer construction (drawings and computer rendered image below) Photos: DWF

Bách sắt chủ 2 liên kết vách bằng đồng định 7

Tru BTCT 150X150

The following technical issues were standardised to make the houses flood/storm resistant:

- reinforcement of the foundations,
- reinforcement of the structure, with reinforced concrete columns (example: 4 steel bars instead of the traditional 3 bars), ring beams,
- reinforcement of the links between roof structure and walls, and roof covering,
- protection of tiled roof with concrete ribs and of corrugated iron sheets, with steel bars in coastal areas (with high risks of strong winds),
- doors and windows which can be securely closed,
- there should be an attic above the flood levels
