## A.21 Pakistan – 2012 – Floods

### Case study

**Emergency:** Monsoon floods, 2012, Pakistan.

**Project location:** Jacobabad and Kashmore districts, Sindh province.

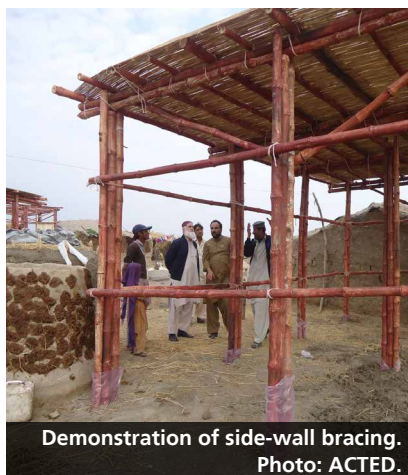
**Demonstration of side-wall bracing.**  
Photo: ACTED.
