# ECUADOR 2016 / EARTHQUAKE

<b>CRISIS</b>	<p><b>Ecuador Earthquake, 16 April 2016</b></p> <p>More than 2,000 aftershocks were felt in the 6 months after the earthquake. 9 of these were equal to / greater than 6 on the Richter scale, adding to the initial damage.</p>
<b>RESPONSE LOCATIONS</b>	<p>Primarily the Provinces of <b>Manabí and Esmeraldas</b> (total of eight affected provinces).</p>
<b>TOTAL HOUSES DAMAGED</b>	<p><b>45,455</b> houses categorized as insecure or of restricted use (Government figures as of Dec 2016).</p>
<b>TOTAL PEOPLE AFFECTED</b>	<p><b>386,985</b> people (as per the Government Register).</p>
<b>BENEFICIARIES OF THE RESPONSE</b>	<p><b>151,699</b> people (38,045 families).</p>
<b>RESPONSE OUTPUTS</b> As of December 2016	<p><b>45,464</b> households reached with NFIs / kits.</p> <p><b>14,581</b> households reached with tarpaulins.</p> <p><b>1,186</b> tents.</p> <p><b>12,178</b> households trained.</p> <p><b>1,453</b> houses repaired.</p> <p><b>2,962</b> t-shelters built.</p> <p><b>505</b> households receiving construction materials.</p>

SUMMARY OF THE RESPONSE

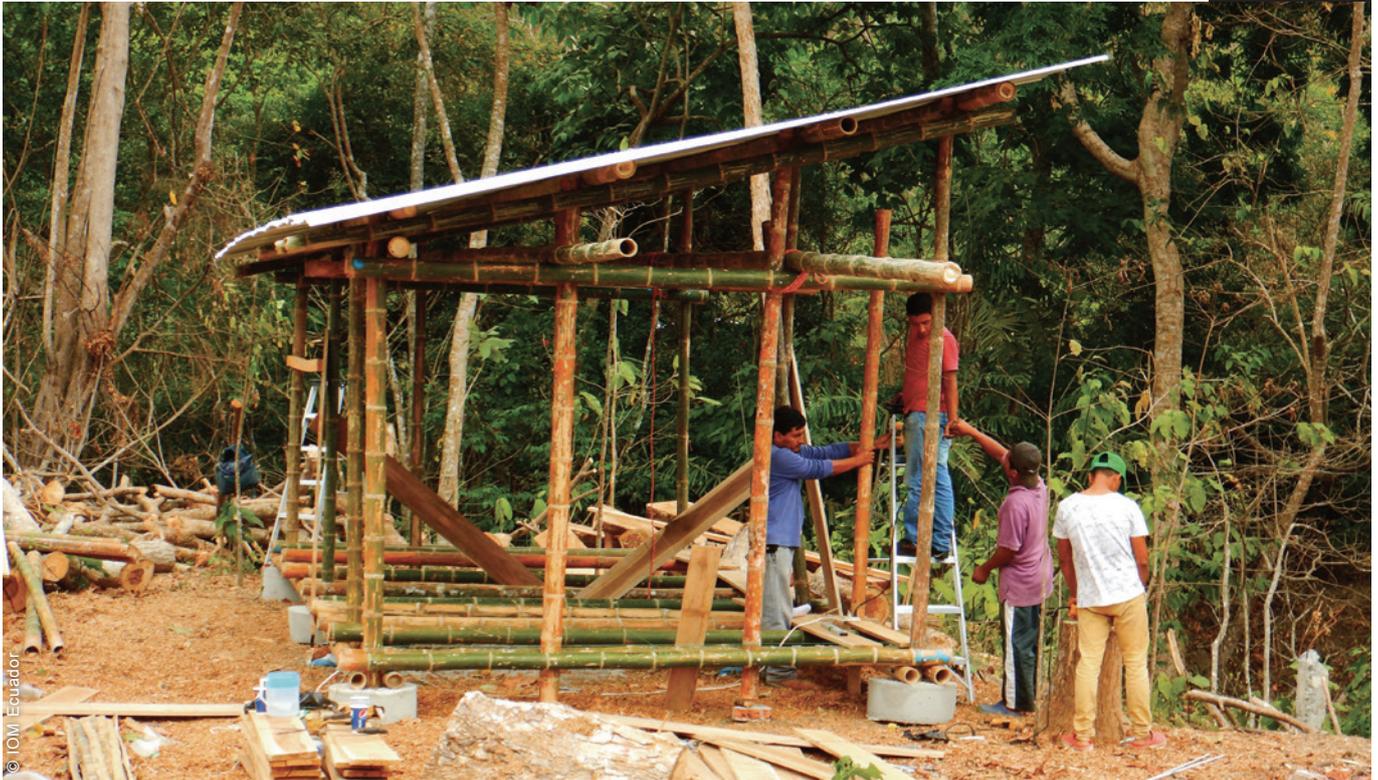
Although initially challenged by the government, many agencies proposed temporary or transitional shelter solutions, that would use local materials (such as bamboo) and provide adequate living conditions in the time span between the emergency phase and the formal reconstruction process (planned by the government).

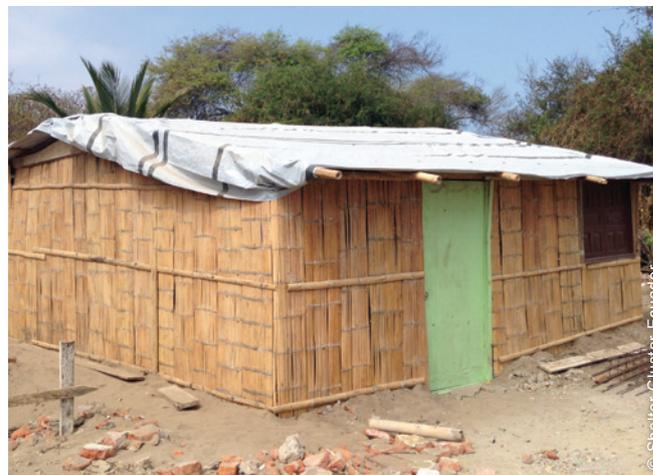
1A : UBICACIÓN DE LA CASA

No construir cerca de ríos o de una zonas inundables.

Es peligroso construir cerca de la costa (riesgo de tsunamis).

No construir sobre relleno sanitario o tierra agrícola.

No construir cerca de acantilados.

Construir separado del muro,os (no adosado y no apoyado).

No construir en barrancos ni zonas de derrumbe.

No construir sobre rellenos.

Mantener buena distancia al borde del relleno.

The first key message from the Cluster in Ecuador, as for other shelter responses, was related to the safe location of houses. Much of the vulnerability of the housing stock was in fact due to the location, often in informal, steep, or generally hazard-prone areas (Source: Shelter Cluster Ecuador and MIDUVI).

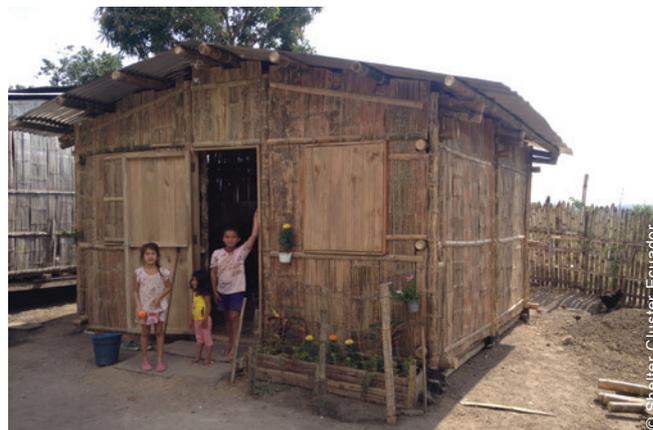
1B : FORMA DE LA CASA

Evitar las formas complicadas, creando juntas sísmicas. Mínimo 10 cm (recomendado 45-60 cm).

Mejor proporción: 1:1 Buena proporción: 1:2 Proporción máxima: 1:3

Cada fachada debe tener al menos una pared llena.

Las paredes deben ser colocadas continuamente, una encima de la otra. ¡del suelo hasta el techo!

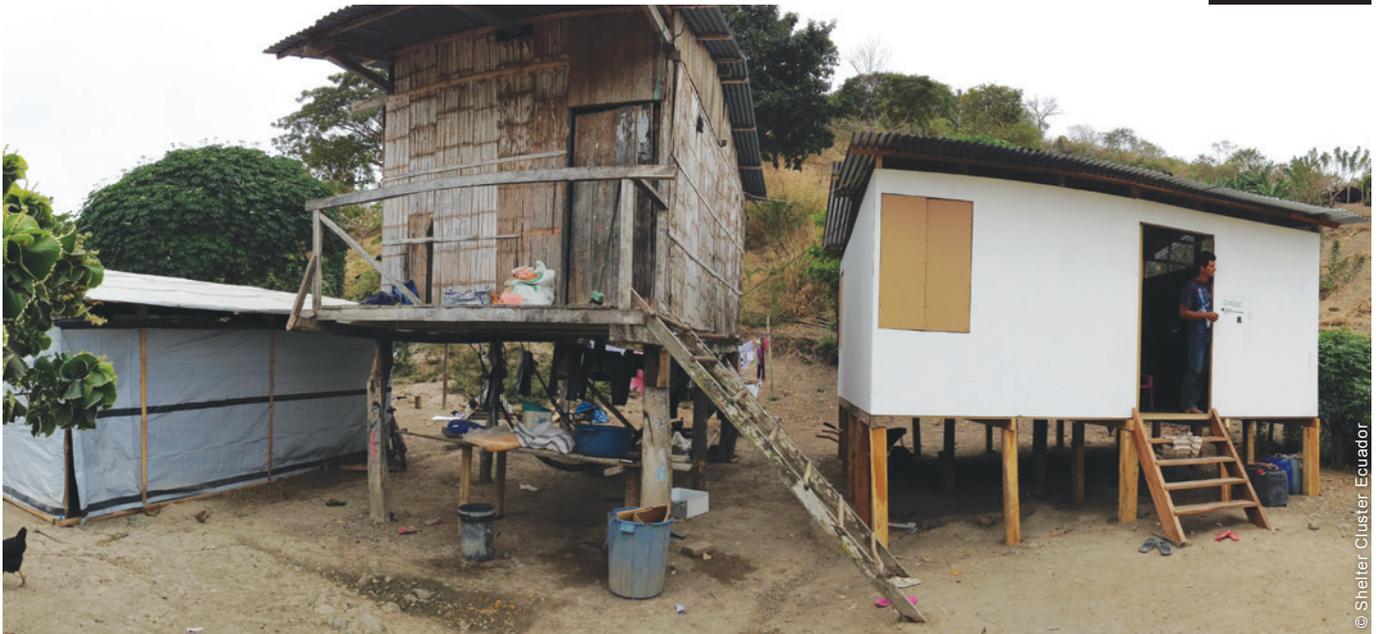
Affected households received either emergency shelter solutions, mainly made of tarps and bamboo framing (left), or transitional shelters that would last longer (right). However, initially there were concerns that solutions seen as more “permanent” would have disqualified people from the government assistance.

Most shelter options supported by the international community used locally available materials, supplemented by CGI roofing sheets or plastic sheeting.

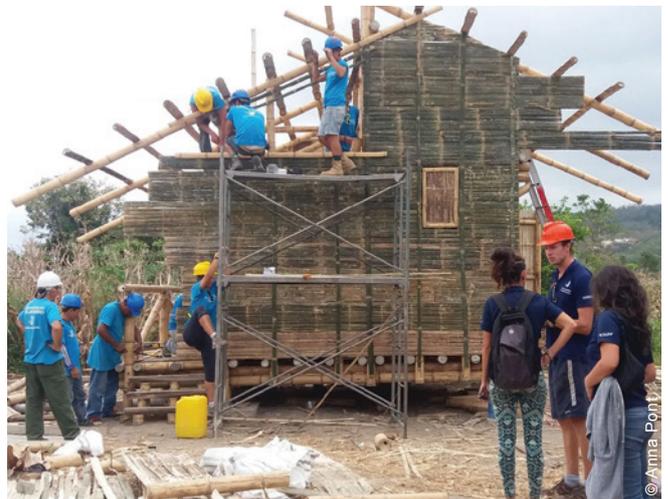
Humanitarian organizations built transitional shelters made of local bamboo, often with the help of volunteers from local NGOs.
