CASE STUDY

BANGLADESH 2019–2020 / ROHINGYA CRISIS

KEYWORDS: Disaster Risk Reduction, Site improvements, Site planning

PROJECT SUMMARY

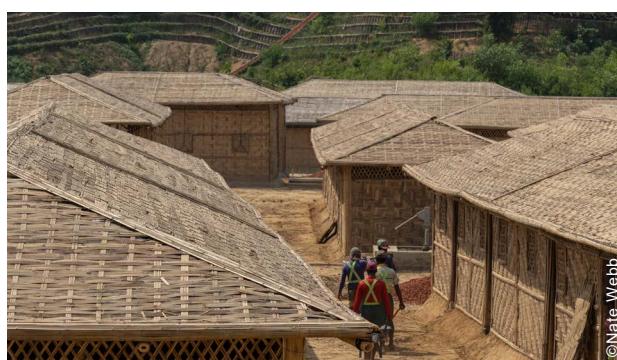
Mid-Term shelters were constructed in the valley areas.

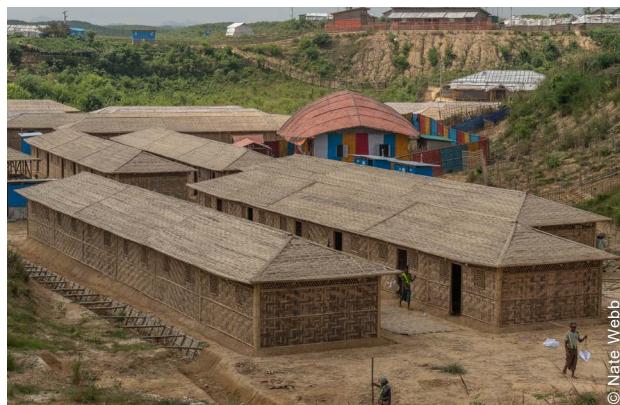
The newly constructed shelters provided accommodation to families who were being relocated from other areas of the camp that were congested or faced disaster-risk.

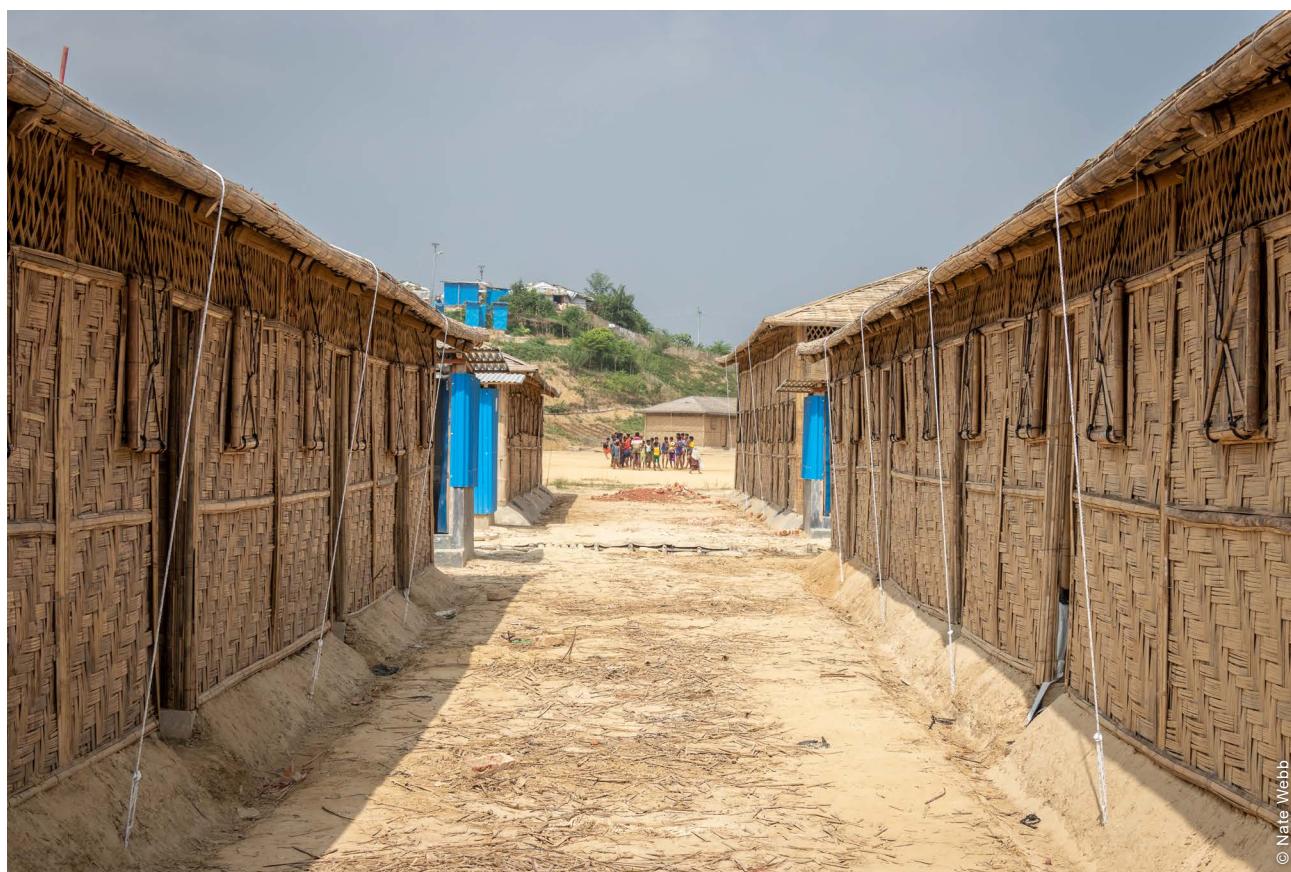
Planning for Mid-Term Shelters was done as part of an integrated site planning and site development approach that ensured space was also provided for infrastructure, community facilities and open areas.

An initial drainage masterplan of the area was developed, creating catch drains around the edge of each shelter area to intercept water washing off the slopes, linked to primary drains through the center of each valley. Soil excavated in digging the primary drains was used to raise the level of the shelters. The project prioritized the use of environmentally sustainable DRR measures, such as using natural drains with earth bedding to promote water infiltration and reduce flood risks for downstream communities, and planting quick growing, deep-rooted grasses along the embankments and on slopes to prevent erosion. In addition to this, several actors carried out major tree plantation and reforestation activities across the camp, to restore the environment, protect the slopes from erosion, and reduce flooding.

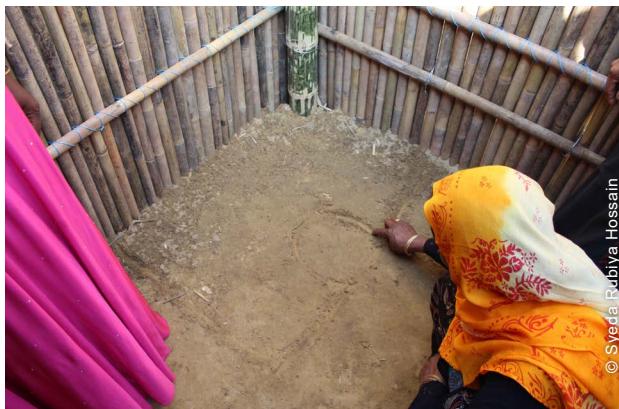
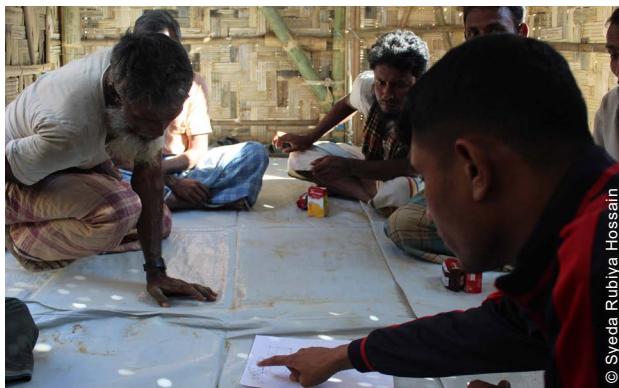
The Mid-Term Shelter design was based on local common construction techniques.

Focus Group Discussions ensured that the inputs of camp residents directly fed into the design of the Mid-Term Shelters.

The shelter technical design was developed in parallel and in accordance to the guidance note prepared within the Technical Working Group of the Shelter/NFI Sector for the construction of Mid-term shelters in the camps. This included reference standards to be met such as the covered space and expected shelter lifespan to be considered, minimum figures for technical aspects such as the plinth height and the free head height to be respected, also roof slope and overhang, recommendations for the materials to be used in the different elements, and DRR features to be incorporated (bracing, wall protection for cooking space, tie-down), as well as considerations related to Protection (internal partition, lockable doors and windows), Health (cross ventilation), and a range of overall cost. The bamboo for the Mid-Term Shelters was treated in the Bamboo Treatment Facility. *For more information on the Bamboo Treatment Facility see case study A.11.*

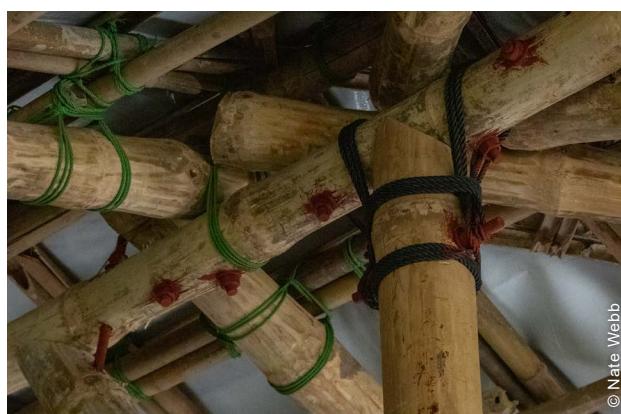
Bamboo for the Mid-Term Shelters was supplied from the camp's Bamboo Treatment Facility.

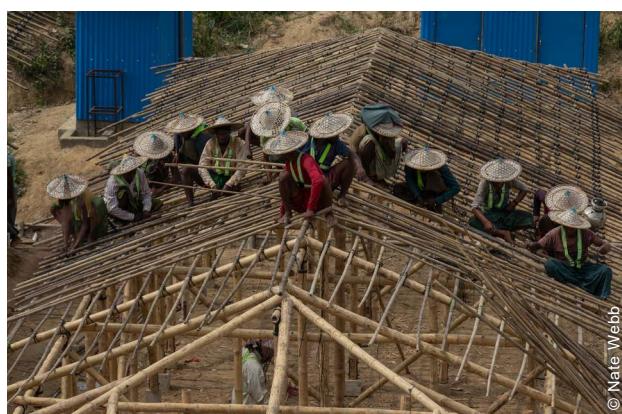
All shelters were constructed by teams of camp residents through Cash-for-Work.

All site development activities and shelter construction was managed through Cash-for-Work (CFW), to provide income generating opportunity and skills training to the community, as well as to foster their ownership. The Site Management agency in the camp managed the recruitment and rotation of CFW labor for Shelter and Site Development teams, according to their requirements and ensuring that vulnerable families were included. At the outset, the intention had been to integrate the female Cash-for-Work participants into the regular activities. However, the women preferred to work in separate activities away from the men, such as producing bamboo crafts.
