CASE STUDY

SYRIAN ARAB REP. 2019–2020 / SYRIAN CRISIS

KEYWORDS: Disaster Risk Reduction, Infrastructure upgrading, Site improvements

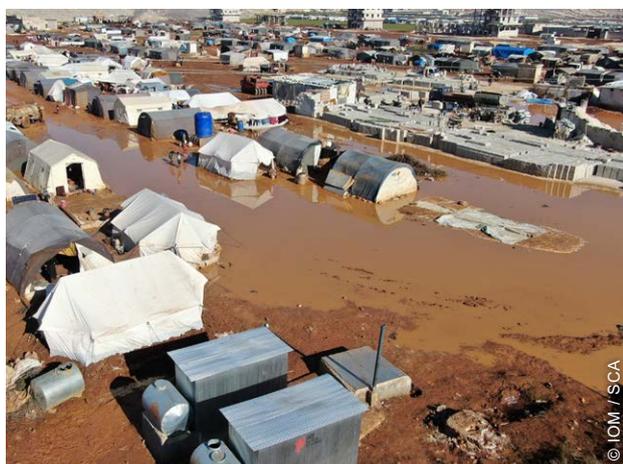
Many self-settled IDP sites have been built in low-lying areas that are at risk from seasonal flooding.

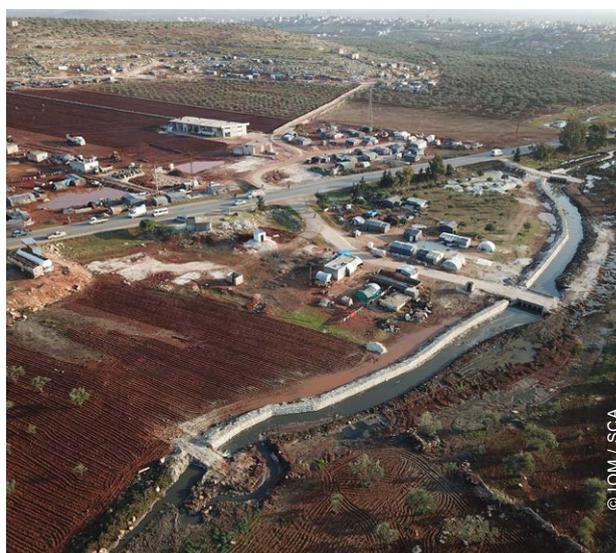
Storm drainage channels were a key site improvement intervention to mitigate the risk of flooding.

- **Inclusion of sewage networks.** It was noticed that residents connected their sewage to the drainage channels due to a lack of sanitation infrastructure. The organization has therefore integrated the construction of sewage networks into a subsequent project.

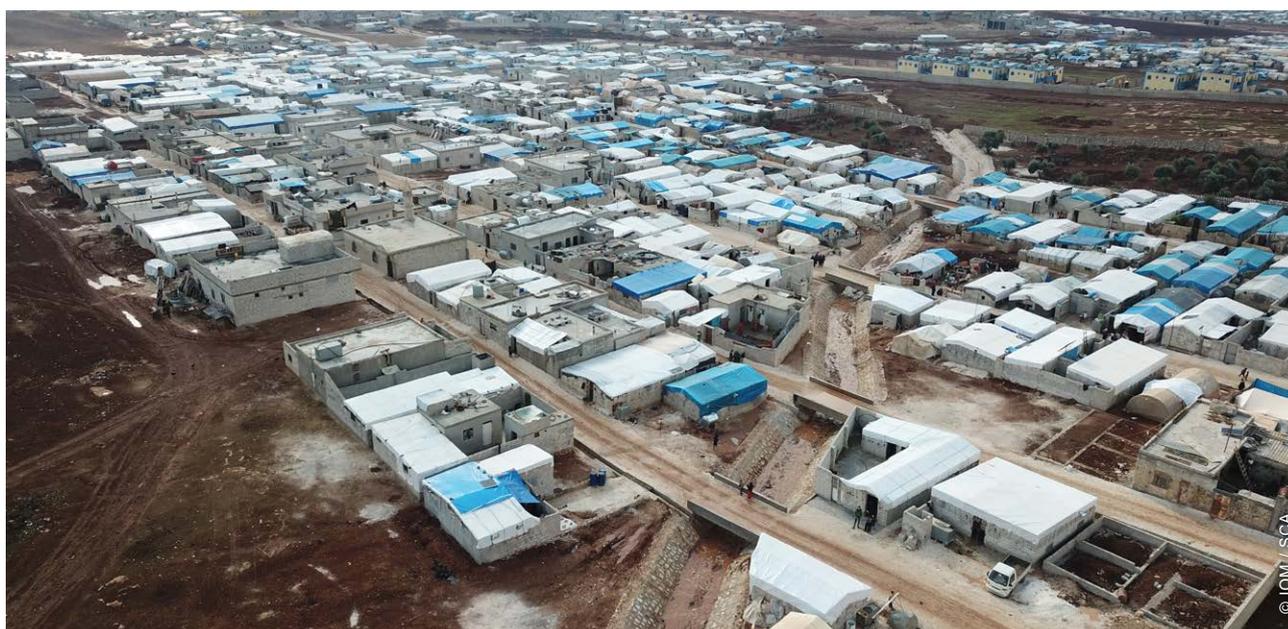
A variety of interventions were carried out based on the needs and technical assessments of each camp. These included constructing open and closed drainage systems, sewage systems, culverts, roads, and raising tents 20cm off the ground through graveling.

The project was in essence a Shelter, WASH and DRR project. A variety of interventions were carried out based on the needs and technical assessments of each camp. These included constructing open and closed drainage systems, sewage systems, culverts, roads, and raising tents 20cm off the ground through graveling. In camps where there was existing infrastructure, the project focused on infrastructure rehabilitation and providing supportive structures. Additionally, to complement the camp infrastructure upgrades, the organization also installed emergency latrines in several of the camps where needed. Coordination also took place with the Early Recovery and Livelihoods (ER/L) Cluster to construct roads leading to several of the camps from the nearest towns and cities.

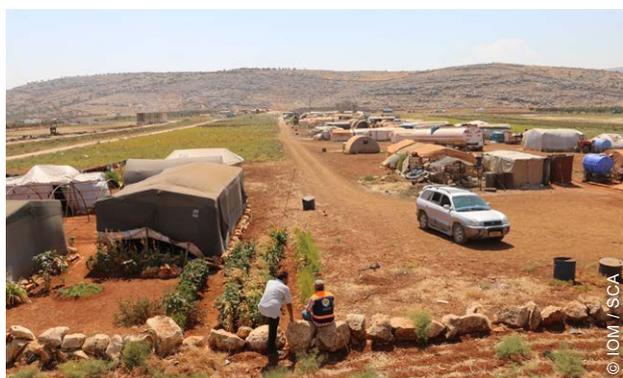
Before: An informal camp pre-flood mitigation intervention.

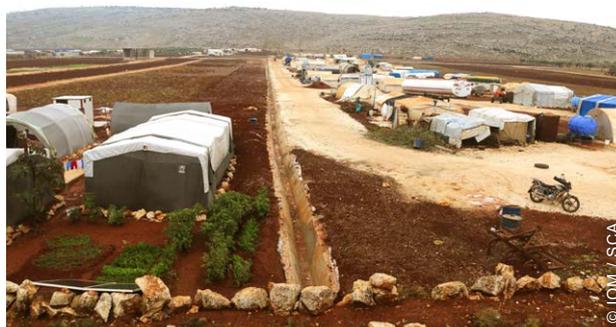
After: An informal camp, post-flood mitigation intervention.
