## CASE STUDY

## AFGHANISTAN 2022-2024 / EARTHQUAKE

## PROJECT SUMMARY

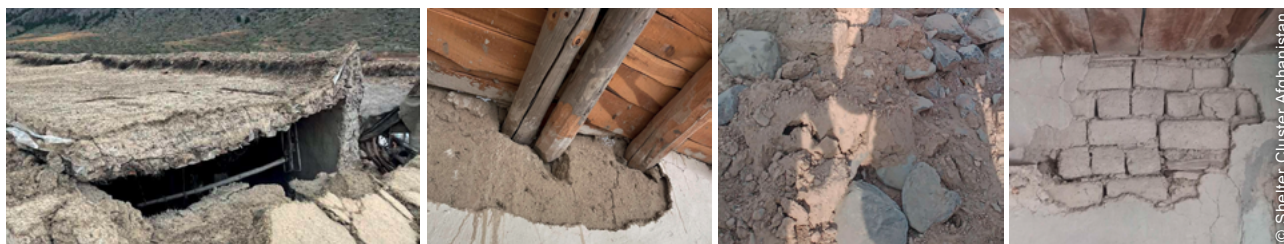
An initial diagnostic following the earthquake revealed common causes of failure, such as rooftop overload and wall bonding issues, for both stone and mud masonry.

Damage patterns were consistent, including collapsed wooden plank roofs; failure of boundary walls often built very high and long without lateral support; rooftops overloaded with thick waterproof clay that gave way;

weak connections between boundary walls and house walls which led to propagation of failures; and poorly bonded stone masonry and mud bricks without adequate overlaps contributing to widespread collapses. These failure mechanisms became the technical compass for reconstruction priorities.

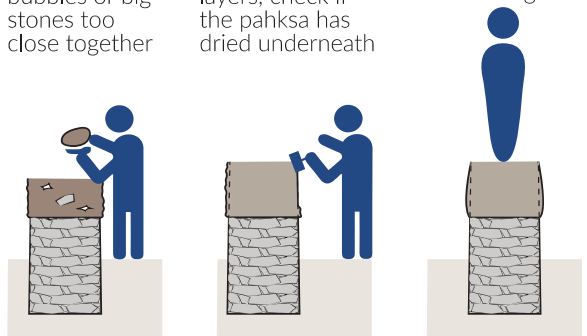
## Pakhsa walls: Control tests

Pack the pakhsa well without air bubbles or big stones too close together

When cutting off the outer side layers, check if the pakhsa has dried underneath

If the pakhsa responds to weight as below, it has not yet dried enough

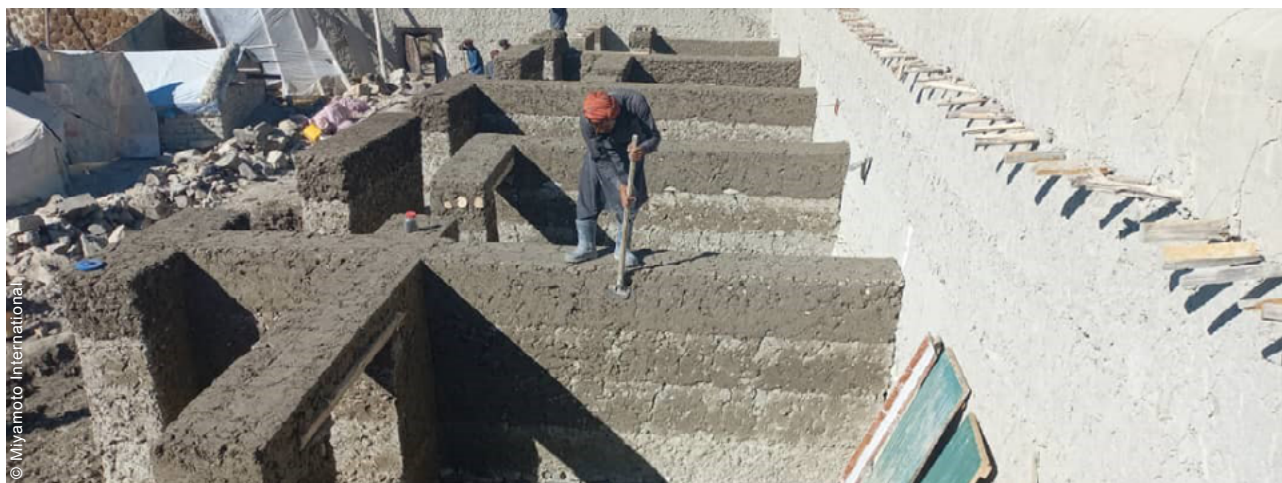
Vernacular techniques were supported through the project, accompanying simple instructions and illustrations for local masons and households.

Focusing on connections, wall bonding and roof assemblies – where failures concentrated – yielded safety gains through modest, locally achievable enhancements.

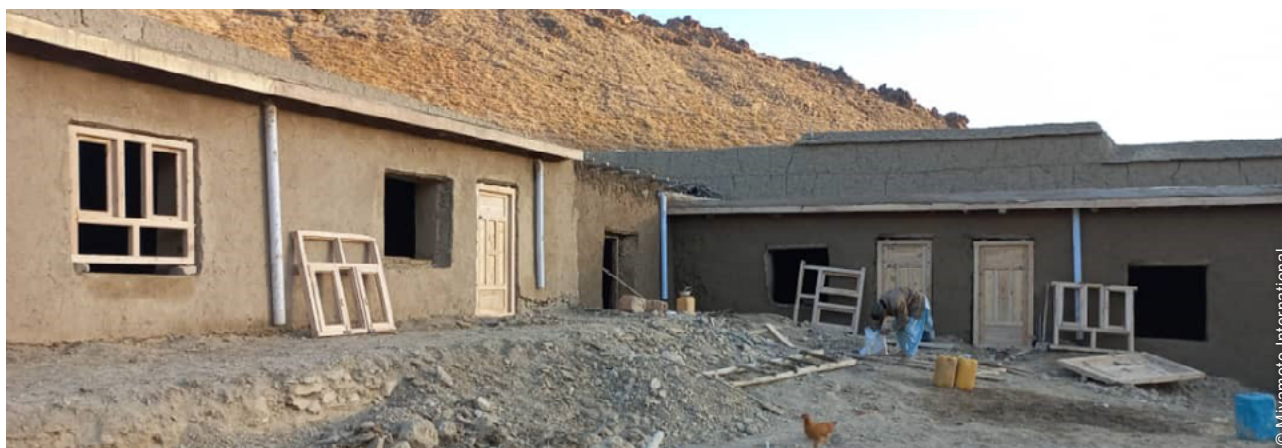
The importance of the compound life was understood and supported by the project, which included boundary walls and clustered configurations in the reconstruction.

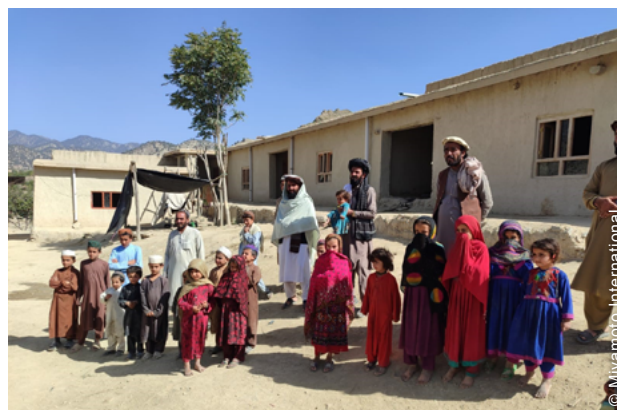
*The cash-based response enabled households to source materials and labour locally, while the organizations supported with technical assistance.*
