CASE STUDY

PHILIPPINES 2023-2024 / TYPHOON ODETTE

| CONTEXT / SETTLEMENT | SHELTER TYPE | SUPPORT METHODS |
|---|---|---|
| PROJECT LOCATION | Municipality of Alegria, Cebu | |

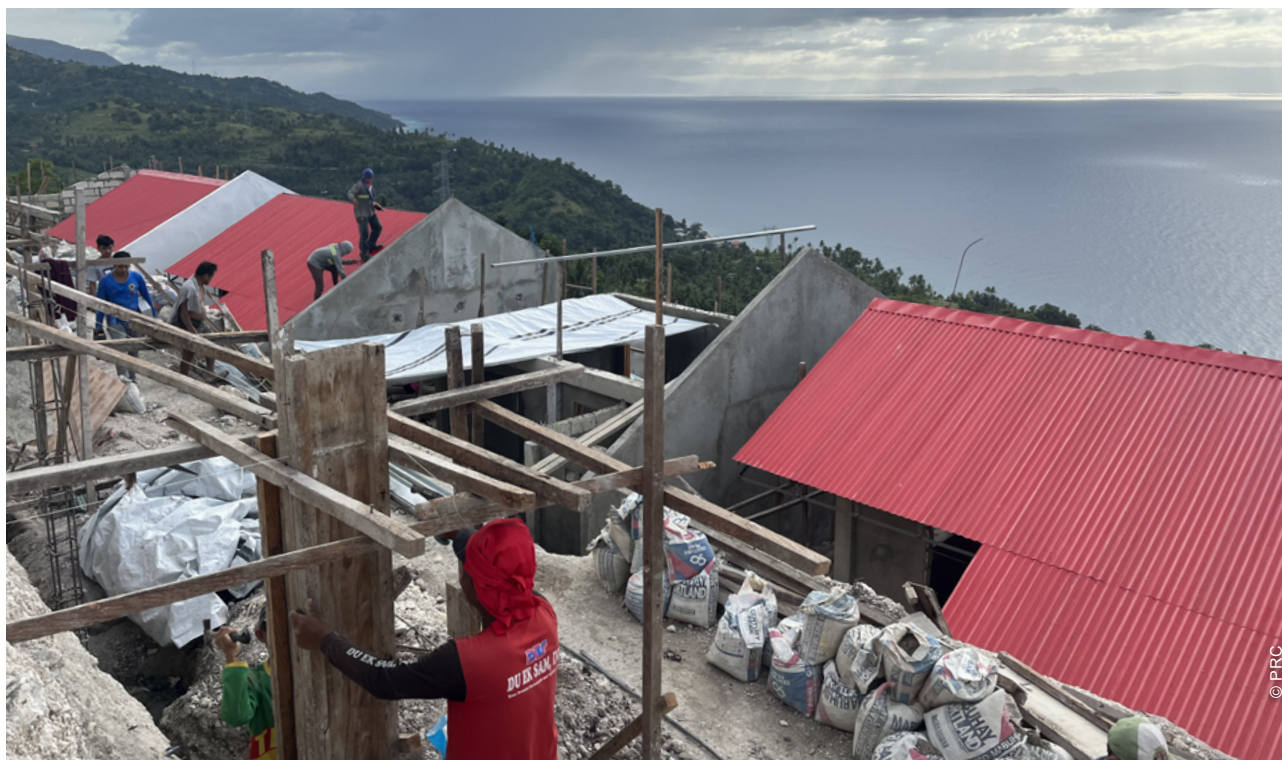
Permanent houses and site infrastructure were built on a slopy site using locally procured resources and labour.

The plot of land provided by the local government was considered suitable for relocation, with low landslide susceptibility, but required substantial terracing and site infrastructure before construction could begin. The steep and uneven terrain made site development a major technical component, including terracing, drainage, access works and retaining structures. During excavation, hidden boulders and variable ground conditions required additional equipment and adjustments to the construction sequence.

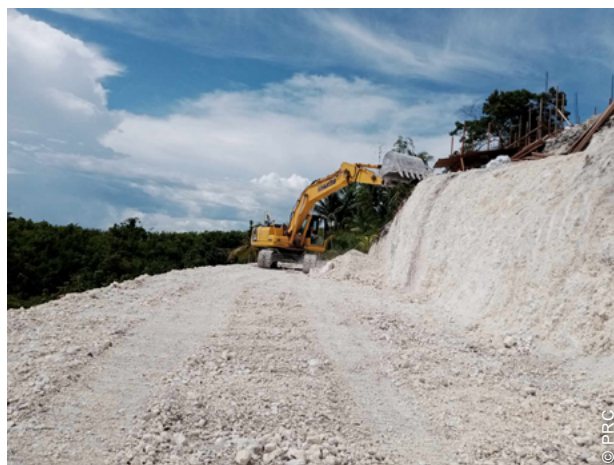
Due to the terrain, unforeseen presence of large boulders and varying soil conditions, site works required heavy equipment and longer than expected.

Procurement and logistics were adapted to local conditions and sources. Technical staff, volunteers, and contractors supported delivery, stock handling, and quality control. As large boulders were found during site preparation, equipment requirements were revised and jackhammers procured to meet the terrain constraints. Settlement-level elements, including solar panels, retaining walls, protective railings, and water line connections, were included to ensure that permanent structures functioned as complete homes within a livable settlement.

The main challenge was the underestimation of front-end site development requirements on steep, terraced land with hidden boulders and variable soils. This affected equipment needs, procurement, logistics and sequencing, and extended the displacement period for some households. Labour availability, material deliveries and delayed water-supply arrangements added further pressure to the construction timeline.

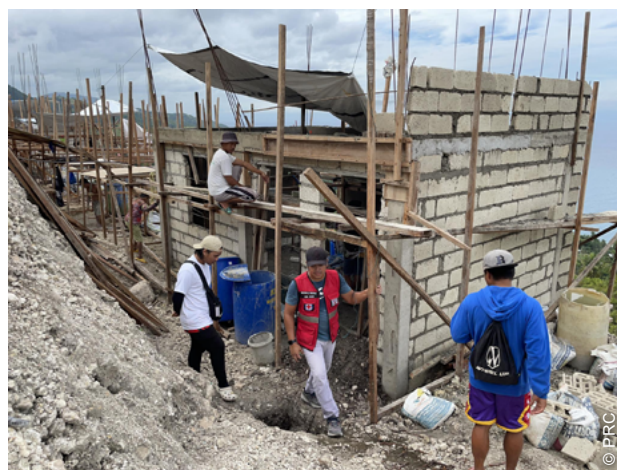
Construction was overseen by project technical staff, local authorities and volunteers.

Local skilled workers conducted housing construction under daily technical monitoring by engineers, technical staff, local authority representatives and volunteers. The structural system comprised single-storey reinforced concrete post-and-beam frames aligned with the National Building Code, with emphasized frame continuity, roof-to-wall connections, anchorage, and wind-resistant roof ties to reduce uplift risk. Quality assurance included daily workmanship checks, pre-pour inspections, reinforcement and roof-frame supervision, and punch-listing prior to handover to ensure defects were corrected. Off-grid solar kits were integrated at unit level to address the absence of municipal power.

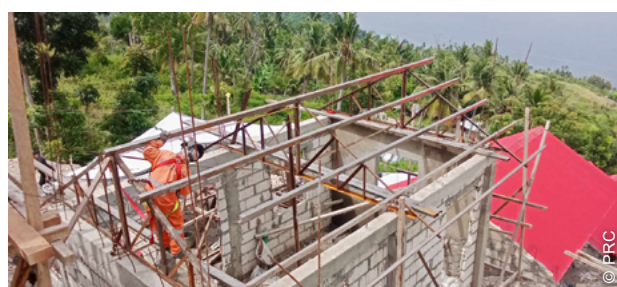
While structural features were fixed, households had a degree of customization on other things, such as the location of the bathrooms.

Community engagement took multiple forms: planning workshops, neighborhood consultations, beneficiary validation, and structured feedback channels. The Barangay Recovery Committee (BaReCom) represented the community, supporting prioritization, transparency, and coordination of on-site activities. While structural safety standards, such as the reinforced concrete frame, foundation depth, and roof anchorage, remained fixed, households influenced non-structural preferences, including choices about sanitation placement outside the main house footprint.

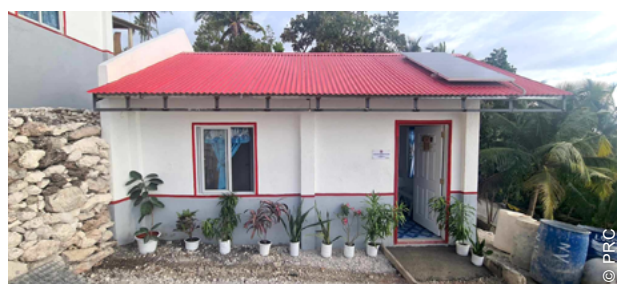
Solar panels were also installed to ensure energy supply in areas with limited electricity infrastructure.

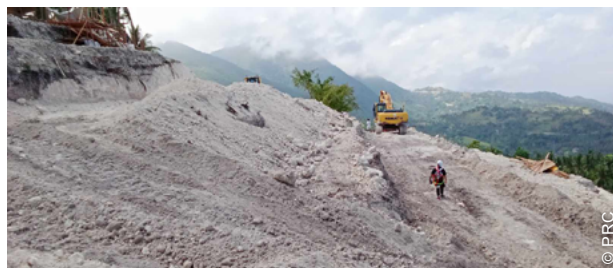
Site preparations were underestimated and required several adjustments.

- × **Front-end site development requirements were underestimated.** Initial assessments did not fully capture hidden boulders, terracing requirements, drainage needs, water-supply constraints or realistic heavy-equipment costs, leading to budget, equipment and sequencing adjustments during implementation.
- × **Construction duration extended beyond the original plan** due to compounded challenges (labour availability, material deliveries, delayed water-supply arrangements), which prolonged the displacement period for some targeted households.
- × **The focus on permanent, high-quality relocation support limited household coverage** compared with overall needs, reflecting a deliberate trade-off between depth and breadth.

- **Prioritize earlier and deeper technical site due diligence** before finalizing budgets, timelines and staffing, particularly where terraced or sloping land is proposed. Minimum checks should include topography, geotechnical conditions, drainage strategy, access, service availability, slope stability and realistic site-development costing.
