CASE STUDY

TANZANIA 2016-2017 / BURUNDI CRISIS

KEYWORDS: Transitional shelter, Adobe brick making, Training, Community participation

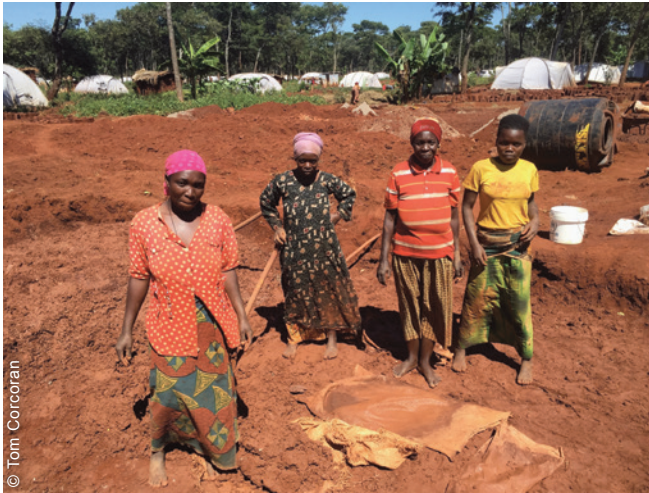
Women were involved in mixing clay, lime and sand (Nduta camp pilot project).

Lime for brick stabilization was chosen over cement due to the high content of clay in the local soil, which hampered the efficient mixing with cement. 2x10kg lime bags were distributed to targeted households, while it was agreed that grass could also be used as a straw mix to protect the outside walls from rain – a technique that has long traditions within the refugee communities in the region. Protective gear was not distributed due to the minimal content of lime, which reportedly did not cause concerns by the users.

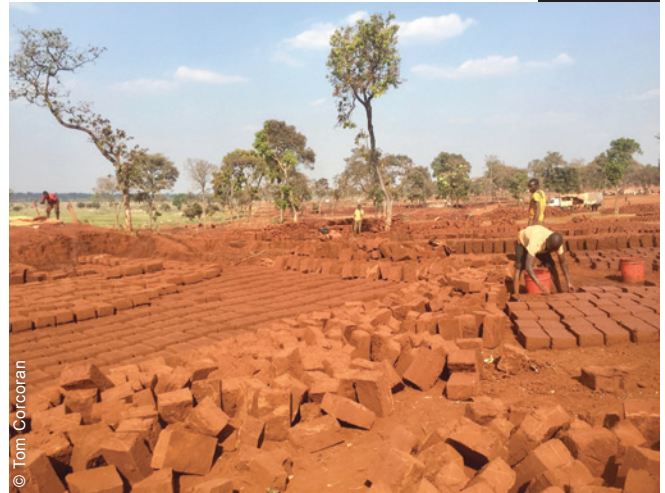
The process of adobe brick making in Nyarugusu refugee camp managed to produce a total of over 11 million bricks, used for the construction of the shelters.

Once partners and the community had agreed on the type of shelter and design specifications, **community-led brick-making commenced in each camp**. Tests were carried out on different lime or cement stabilized bricks throughout the project, as variations in soil were encountered in different areas of the camps. It was initially decided to use lime, but later in the project the team discussed the suspension of lime distributions, mainly due to its scarce effectiveness in such minimal proportion, fear from some users that it would irritate their skin, and the fact that families did not use it at all in one of the camps. Brick-making was carried out in groups of 16 households, overseen by one full-time supervisor (foreman) from the implementing agency. Each group included at least one family with persons with specific needs. The bricks were air-dried and could therefore be produced in any weather, as long as cover was provided during wetter months.

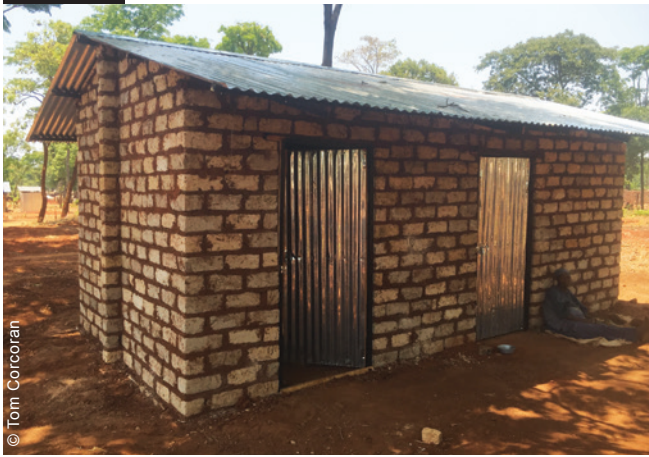
Duplex lime-stabilized shelter completed in Nduta refugee camp. Some of the shelters were designed to host two small families and followed the same design, but had two doors and a partition that divided the indoors in two units.

The adobe brick shelters were 18m² which accounted for the average household size (five members). Small families and individuals were provided with “duplex” shelters. These were of the same size, with a partition wall in between and two separate doors to each of the rooms. 975 shelters also had a 4m² kitchen attached, built under a different project, which included the use of gas stoves.

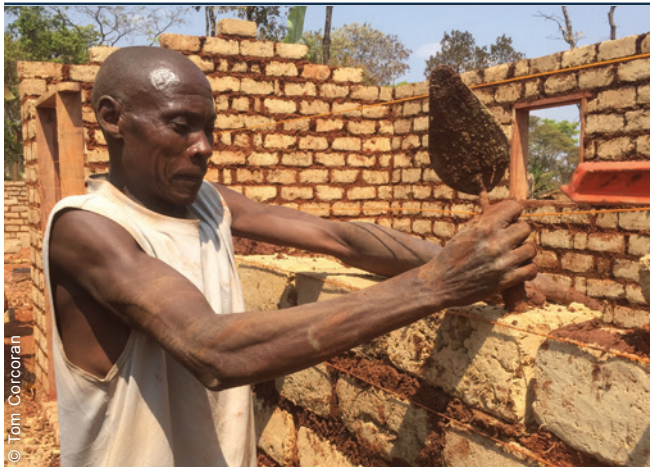
Mason laying the bricks of a shelter in Nduta refugee camp. Skilled builders from the refugee population were employed for the construction of the shelters.

Once the bricks were produced and transported to the family plot, **a trained builder from the refugee community was assigned to each household to support the masonry work**. Households were responsible for mixing mortar, carrying water and other general activities. Following this, a carpenter

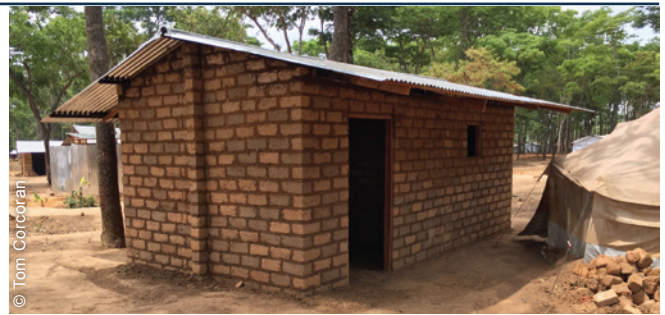
Lime-stabilized transitional shelters were built in Nduta refugee camp. The emergency shelter solution (tent), where the family was living during the construction, can be seen on the same plot near the shelter.

Each targeted household was assigned a construction plot within the camp. In Nduta camp, the plot was 20x15m, making it possible to construct the new shelter while the family continued to occupy their tent or emergency family shelter on the plot. In Mtendeli and Nyaragusu, the plot was 15x10m, making simultaneous construction more challenging. If living in tents, families were recommended to move their tent to the firebreak (or another space) while construction took place.
