OVERVIEW BANGLADESH 2017–2018 / ROHINGYA CRISIS

CASE STUDY BANGLADESH 2017–2018 / ROHINGYA CRISIS

KEYWORDS: Site planning, Coordination, Disaster Risk Reduction

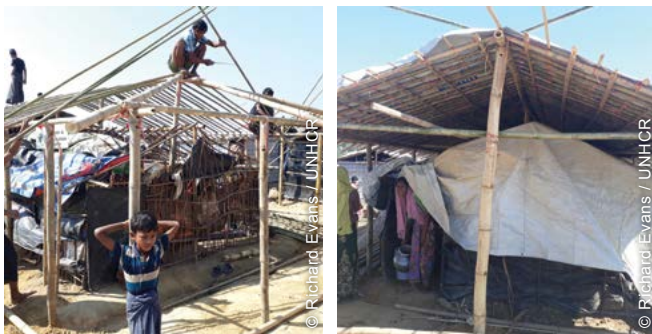
Refugees often used upgrade materials to build over old makeshift shelters.

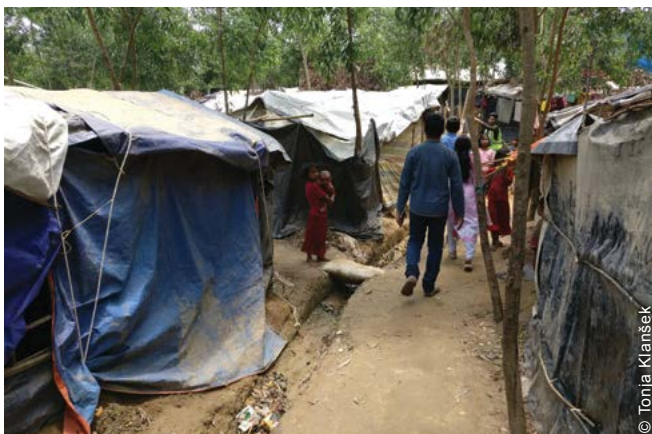
Makeshift shelters before the implementation of the upgrade phase of the shelter response were small, often fragile and highly vulnerable to weather hazards.

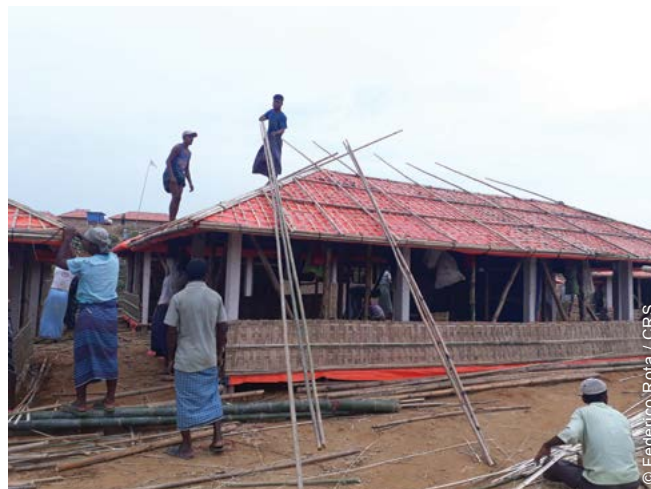
In phase 3, the Shelter Sector started to implement more durable solutions, such as Mid-Term Shelters.

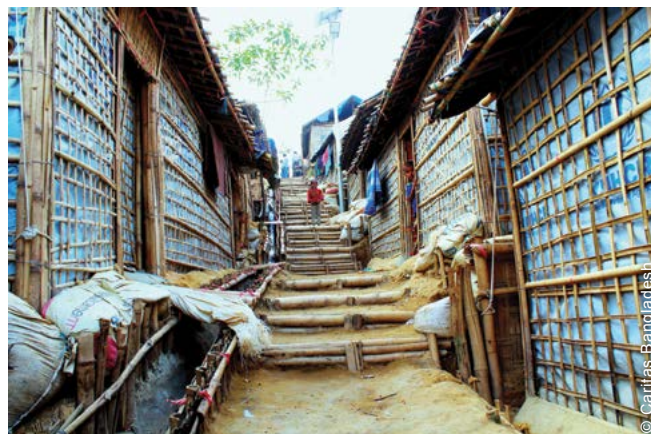
Shelter upgrades and localized site improvements (such as footpaths, stairs and drainage channels) were conducted in phase 2 to make living environments more adequate and protect households from the upcoming monsoon season.

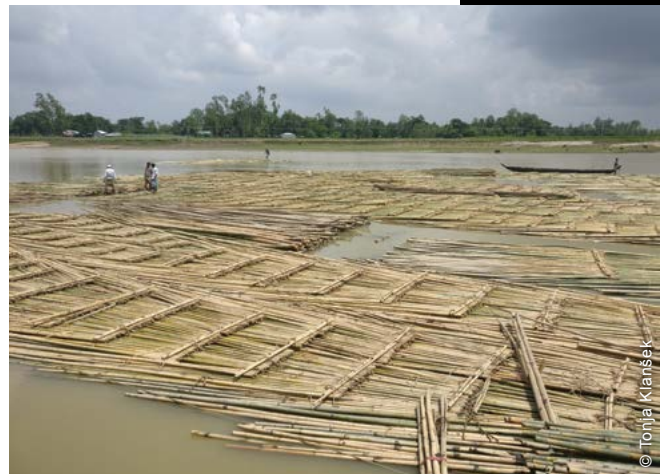
Millions of pieces of bamboo were needed for the shelter response, as well as the construction of community facilities, bridges and other site improvements. Bamboo was mainly transported by river from the Chittagong Hill Tracts area.

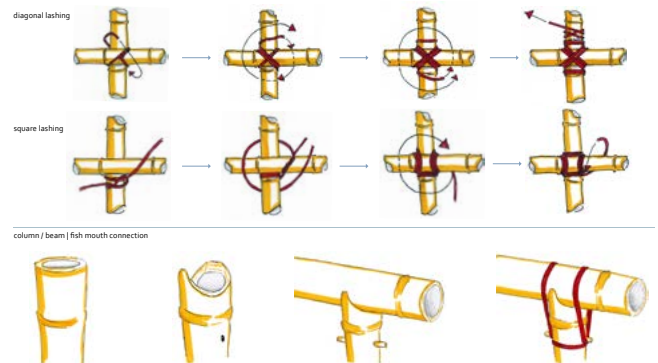
To support training activities, the Sector developed key messages and illustrations on shelter upgrades, such as bamboo ties and connections.

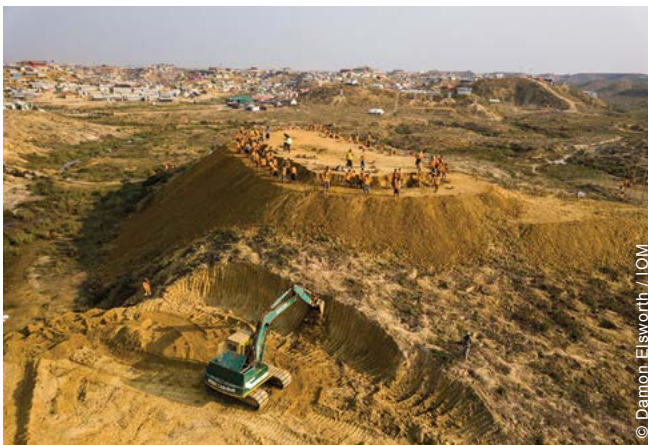
The Site Management Engineering Project was instrumental in conducting large earthworks to modify the challenging landscape.

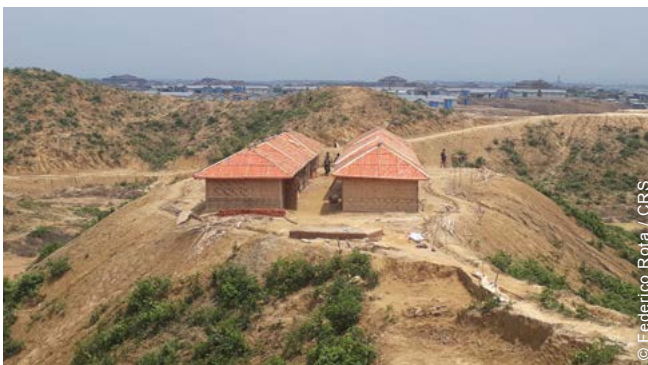
In the third phase of the response, Mid-Term Shelters were built on plots already prepared by site development partners.

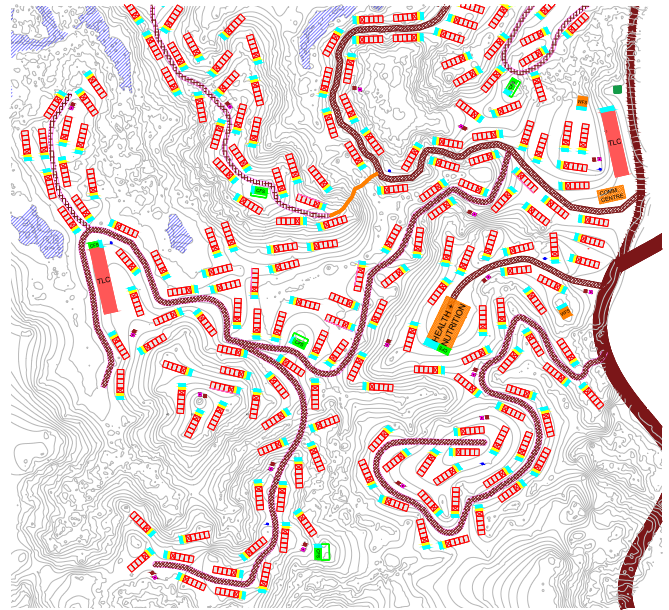
Site planners started to draw the first plans following minimum agreed standards in October 2017, and some of the expansion zones were prepared in advance of refugees settling (Plan: Phoebe Goodwin / UNHCR).

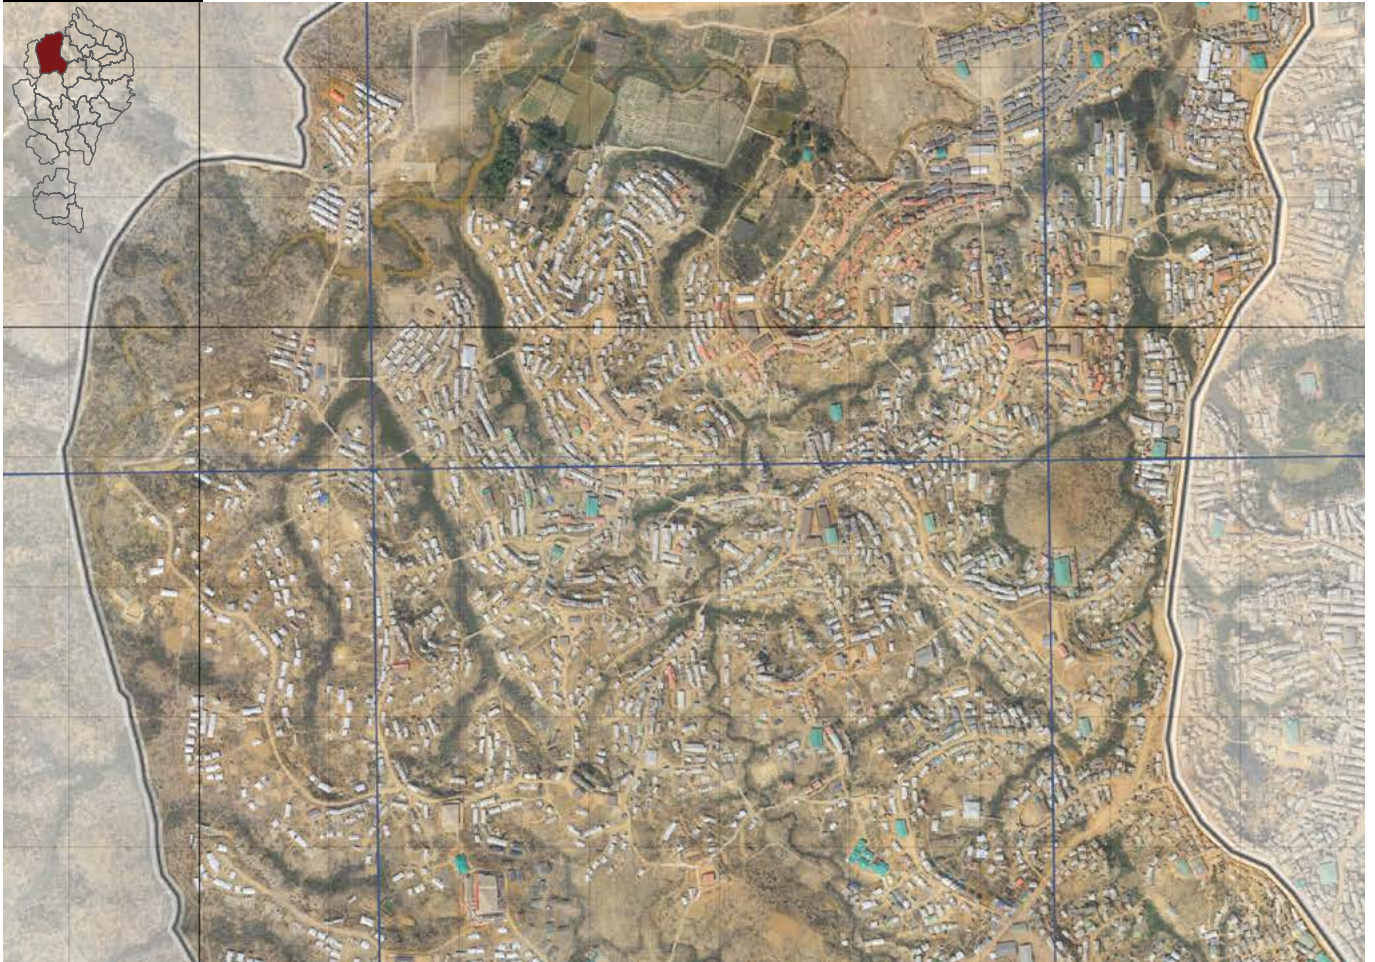
Drone image of zone OO after refugees settled, in February 2018. Densities were lower here than in other parts of the site, and services were relatively well distributed. However, this also meant that assistance was not evenly spread throughout the site, as other areas remained very dense and lacked services (Source: NPM, 14 Feb 2018).

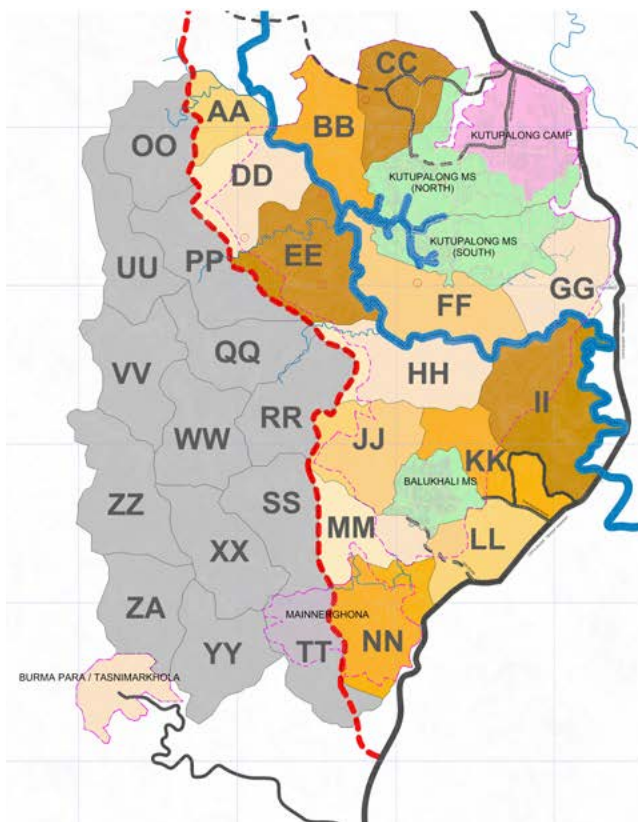
The army road was opened along what used to be the western border of the KBE site at the time it was designed, before the further expansion in the grey zones. The humanitarian community used the notation AA–ZZ for about four months, to divide zones of comparable size (Source: ISCG, 30 Sep 2017).

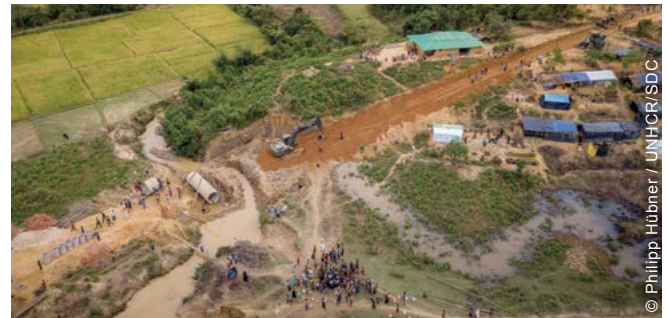
Major infrastructure (such as the Army road and culverts) was needed to convert a forest land into a liveable settlement.

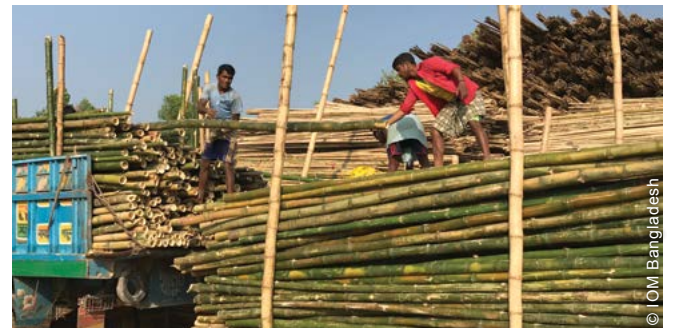
The procurement and logistics for the bamboo required for 100,000 kits needed a large dedicated team and the application of expedited procedures. Because of time constraints, bamboo was untreated and often harvested hurriedly.

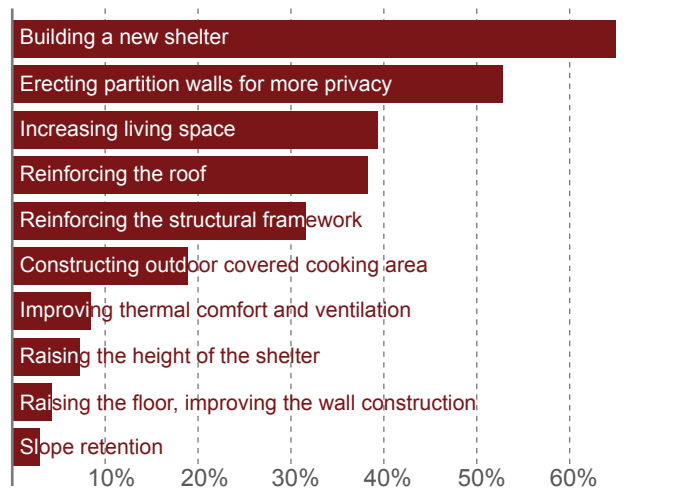
This chart shows how USK items were utilized according to the respondents of the shelter survey, who were asked what their top three uses of the kits were.

Post-distribution monitoring indicated that over 99 per cent of the shelters had some sort of improvement after receiving the materials and training. Yet this finding is not surprising given the poor shelter conditions prior to the distributions and the total lack of shelter materials in the settlements. Further, the Sector shelter survey showed that training and technical assistance were well received by refugees, with 99 per cent of those who received it considering it useful or very useful. 97 per cent of the surveyed households also stated that they would like to receive either more training or more technical assistance. During focus group discussions, respondents identified three main learning elements from the training: tie down of the roof, anchoring and improvement of foundations, and making strong connections. On the other hand, bracing was considered less relevant.³

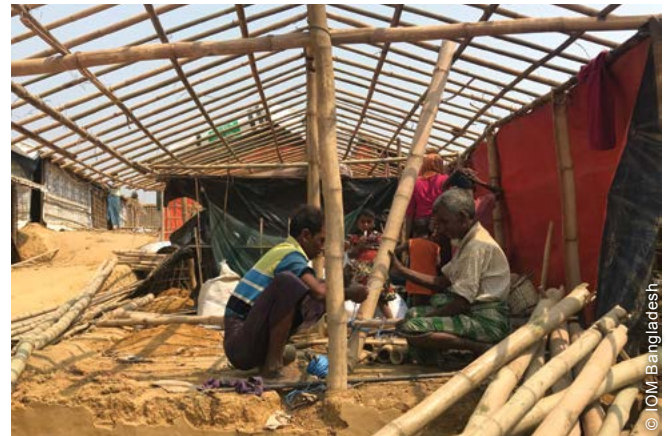
Although the training and technical assistance were well received, many refugees thought the materials in the kits were not enough and generally did not consider bracing as relevant.

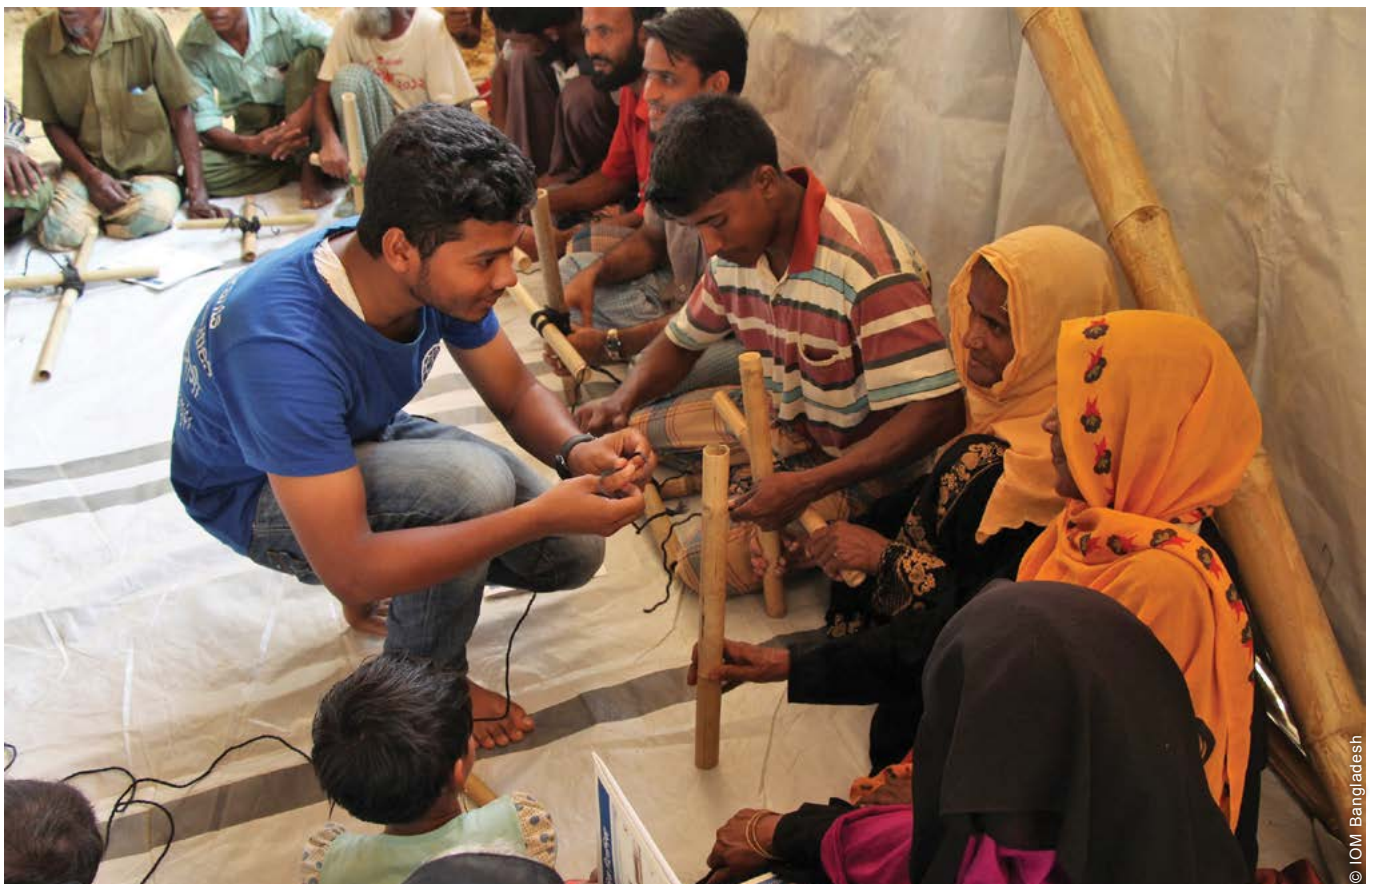
To reach over 43,000 households in about four months, resources were well allocated with a combination of in-kind and technical assistance. Hands-on sessions with maximum 25 participants were conducted for refugees on the day of the distribution. The training was generally welcome and allowed over 99 per cent of beneficiaries to make improvements to their shelters.
