OVERVIEW

NEPAL 2015–2018 / RECOVERY

CRISIS	Floods, 11 August 2017

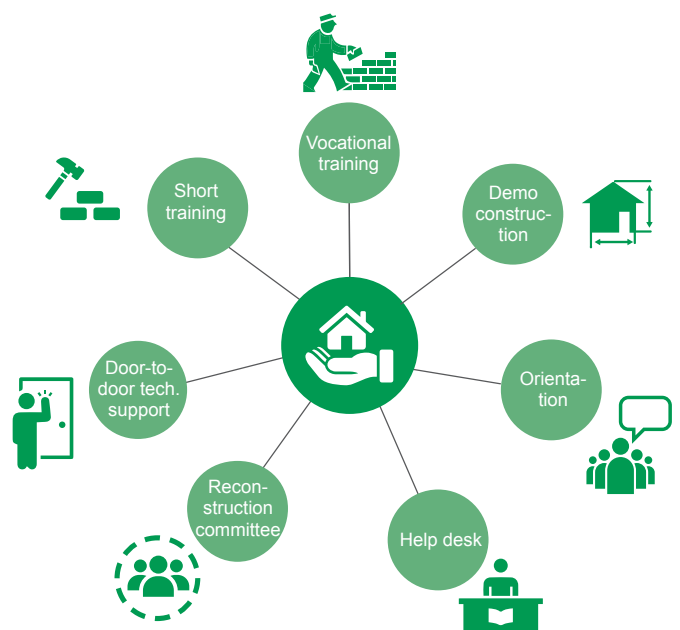
CORE SOCIO-TECHNICAL ASSISTANCE PACKAGE IN NEPAL

Basic STA package in Nepal. STA is not a one-off activity (Diagram: HRRP).

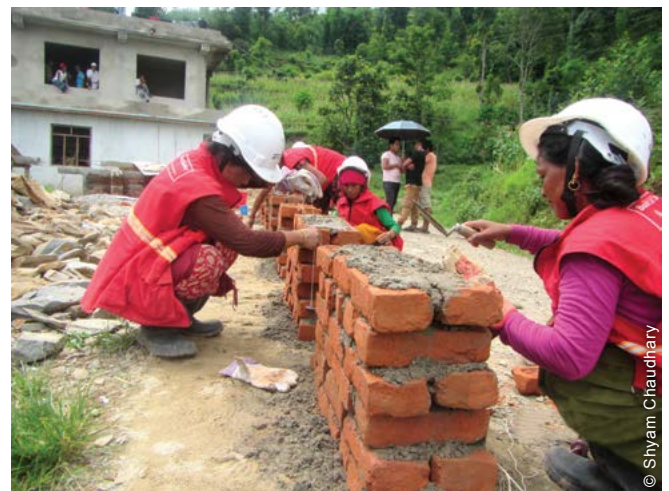
Vocational trainings included practical sessions on seismic resistant construction techniques. 38 per cent of participants were women.

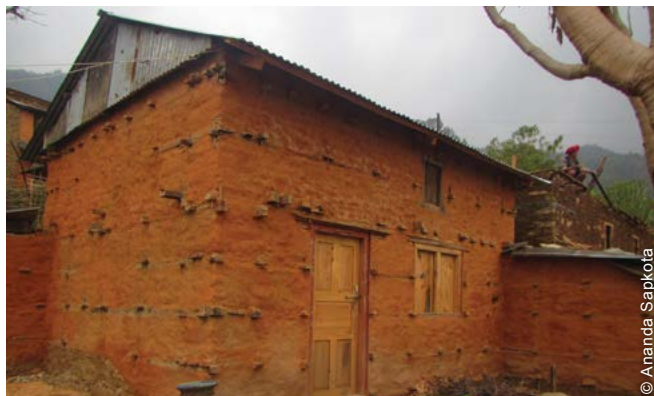
Designs were flexible and allowed the use of local materials without compromising on compliance with the building code.

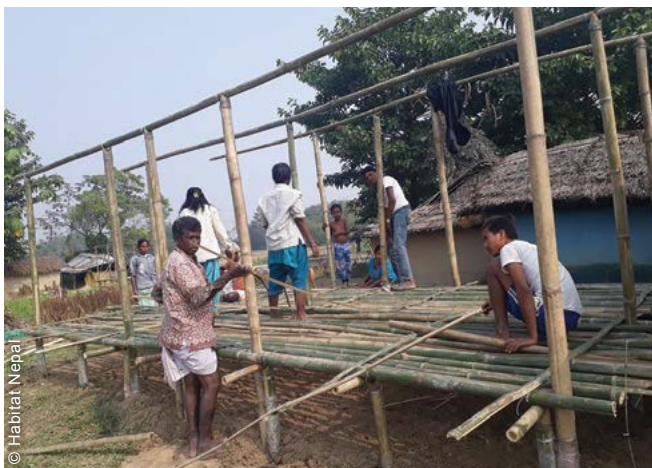
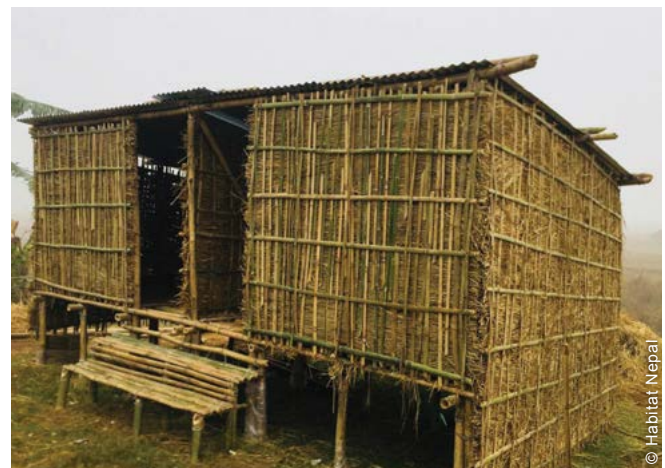
The project provided emergency shelters for flood-affected populations using local materials, and was implemented by local organizations who trained community members on bamboo construction techniques.

The main frame of the shelter was made of untreated bamboo. Treatment was not used due to the temporary nature of the shelters and the decision to prioritize the scale and timeliness of the response. The walls were made of tarpaulins that could be later replaced, while the roofing was made of corrugated galvanized iron (CGI) sheets.

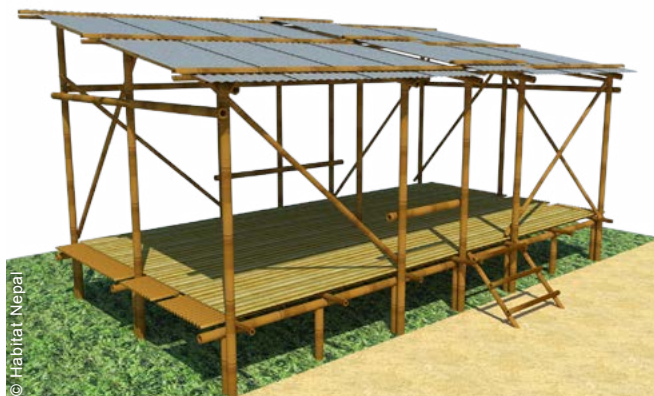
- **The central CGI sheets were raised** by an extra layer of purlins to allow the heat to escape from the gap created at the top. The high ceiling was also aimed at providing better ventilation.

- **Bamboo bracings** were used to strengthen the frame by making it a single structural unit.
- **Connections** were done with lashings.
- **Anchorage** was used to increase stability.

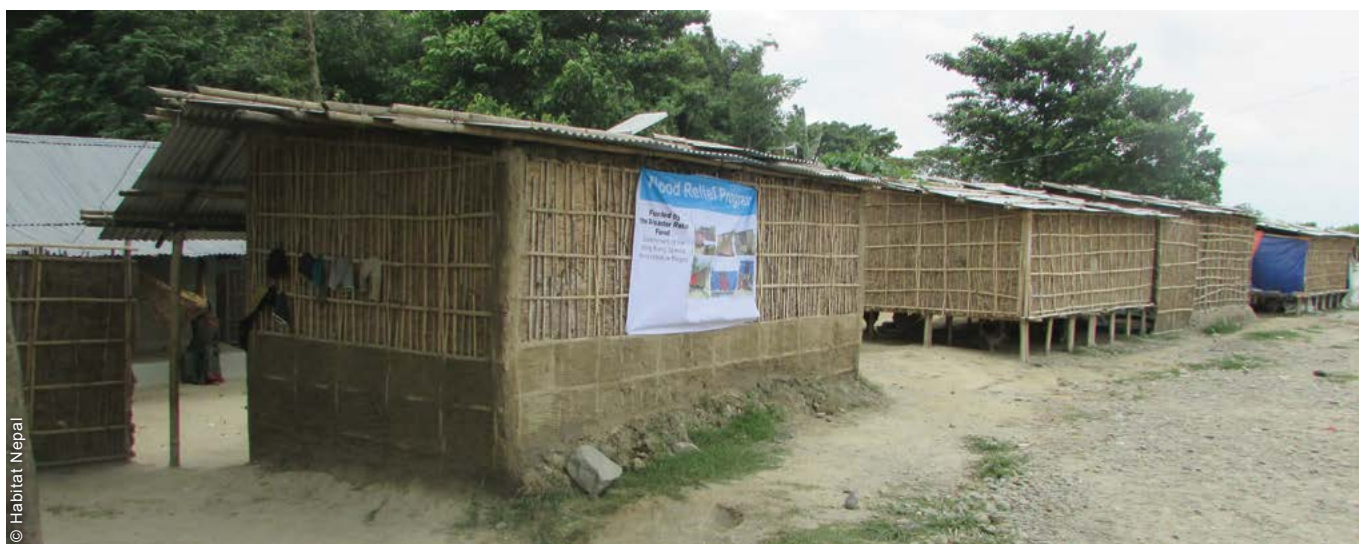
Shelters included mitigation features, such as raised floors, bracing and secure connections, and allowed for some adaptations, such as the upgrade of floors and walls.

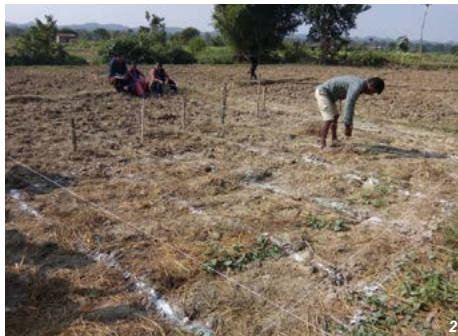
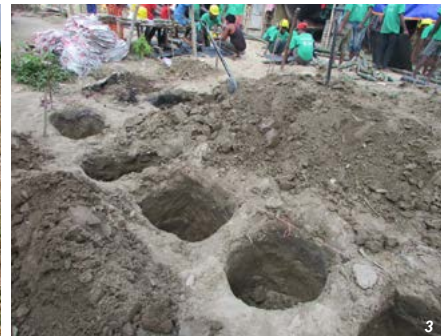
Left (1): Draw lines for foundation according to the dimensions and place the stakes in the ground. Check whether the stakes are at right angle using the 3-4-5 method. Centre and Right (2-3): Dig 21 post holes of 2' x 2' in the ground. (Photo credits: Habitat Nepal).

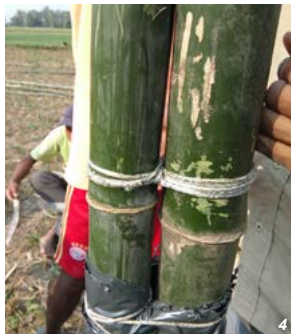
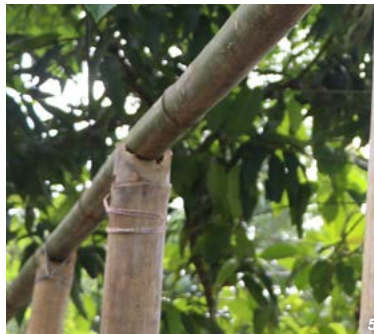
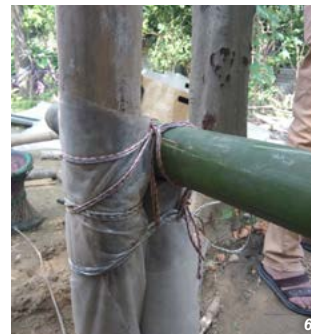
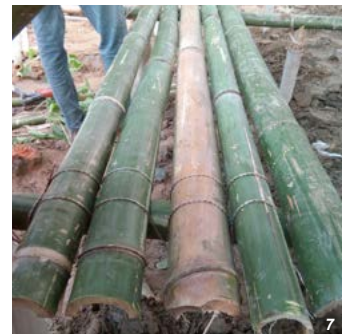
Left (4-5): Cut the required length of floor and roof posts with saw, tie them together and wrap them with polythene sheet. Cut the upper ends of the posts with a fish-mouth cut. Right (6-7): Place and tie floor beams to the bamboo floor post with rope. Place the next set of beams on top, perpendicular to the beam below. Place split bamboo joists above the floor beams. (Photo credits: Habitat Nepal).

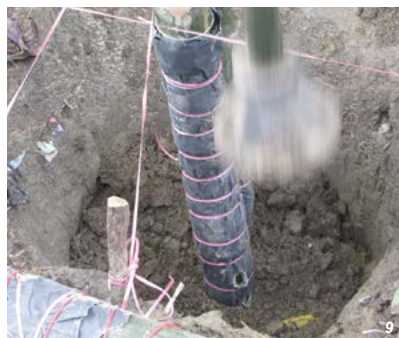
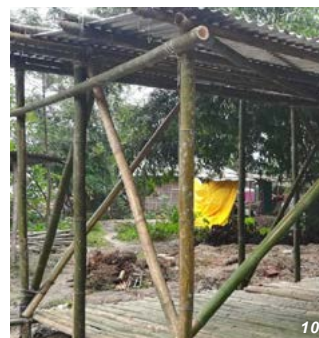
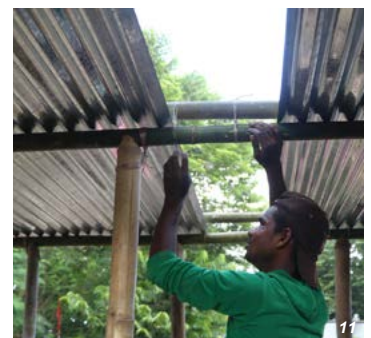
Left (8-9): Tie bamboo posts to the anchorage and place it inside the post hole. Then fill the hole with debris and tamp using wooden tamper. Right (10): Tie diagonal bracings of required dimensions to the roof post. Then tie the horizontal bracing at lintel level. Place the roof beams on top of the bamboo post and tie with rope. Place the cross bracings at roof level and then tie to the beams with rope. Right (11): Place bamboo purlins on top of the roof beam and tie with rope. Arrange 8 CGI sheets over them leaving one sheet width vacant in the middle. Tie 2 layers of purlins together to hold the CGI sheets in place. Place the remaining CGI sheet over the void and place 3' length purlins on top of each purlins below to hold the sheet down. This provides air movement inside the shelter through the roof. (Photo credits: Habitat Nepal).

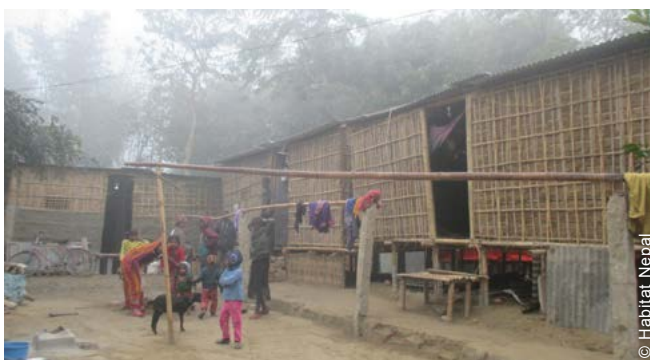
Materials and designs were culturally appropriate and designed in consultation with the affected households. After the project ended, families were already upgrading the shelters and it was expected that these could last for up to two more years, if properly maintained.

The minimum lifespan for the shelters was estimated at six months, but it could be prolonged with regular maintenance, repairs and protection measures from the elements. Early observations after the project was finished showed that beneficiaries were already upgrading the original shelters, for example by substituting worn plastic sheeting on walls with bamboo mats and plastering, improving floor finishes and installing more secure windows and doors. This was mainly because bamboo was a locally known material and households and local masons had been involved in the construction process. A year after the completion of the project, families were still living in the shelters and it was expected that the structures could last for at least another year or two. It was also anticipated that, depending on the longer-term solutions for each household, the temporary shelters would continue to be used, either by recycling the materials or giving alternative uses to the shelters.
