CASE STUDY

# SRI LANKA 2017 / FLOODS

**KEYWORDS:** Housing repair, Transitional shelter, Evacuation centre upgrade, Disaster Risk Reduction, Community-based organizations

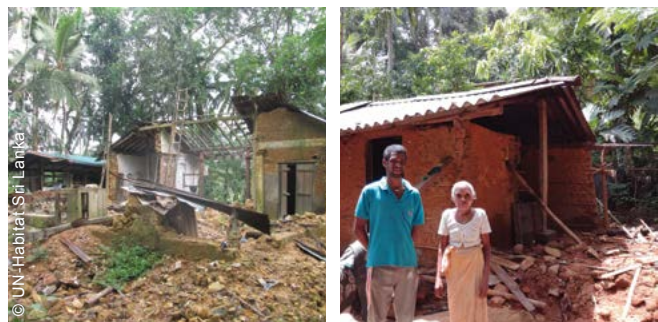
The 2017 floods caused extensive damage, especially in rural areas.

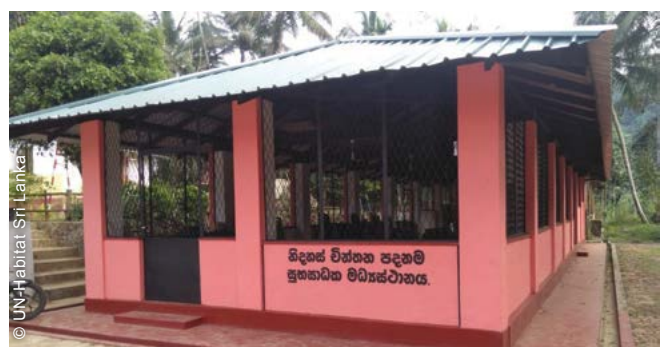
People displaced by the floods found shelter in public buildings. The project upgraded such evacuation centres in cases where families could not go back quickly.

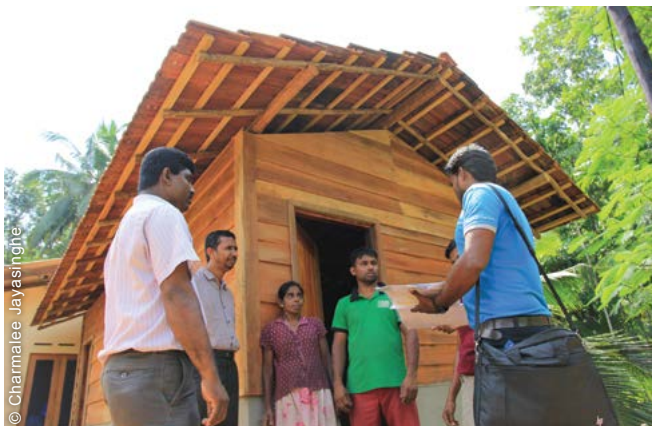
For very vulnerable households with a completely destroyed home, cash grants were given to build a transitional shelter.

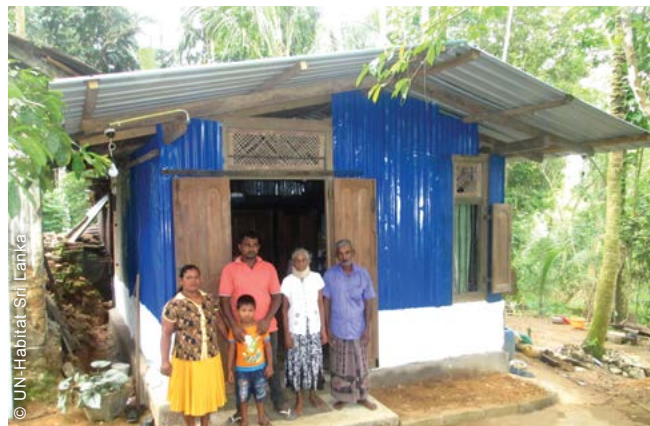
In some cases, transitional shelters were also built using salvaged materials.

Reclaimed materials were used to reduce costs by decreasing the procurement of new materials and limit the environmental impact of the disaster by recycling debris. Affected households recovered roof tiles and timbers, doors and windows damaged by the disaster, stored them on site and reused them both for repairs and new construction. The debris available on site (such as bricks and concrete rubble) were sorted, cleaned and reused as aggregates into foundations and as floor concreting.
