The following is an excerpt from the book [Post-disaster shelter: 10 Designs, IFRC, 2013](#). Inclusion of this design is for information purposes and does not necessarily imply best practice. Designs are site specific.

## B.9 Pakistan – 2010 – ‘One Room Shelter’

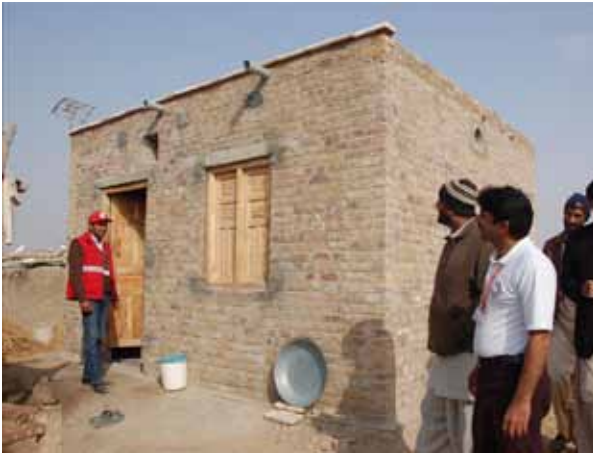
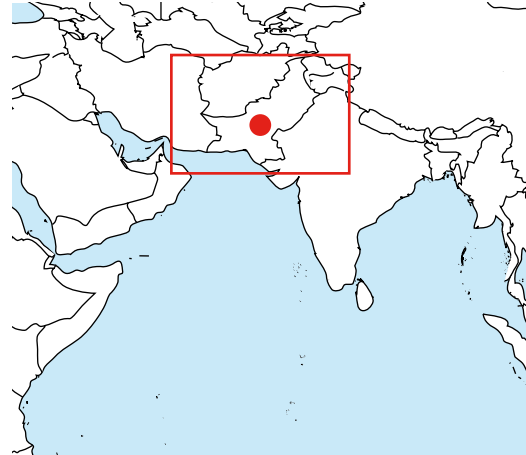
This shelter is a rectangular structure with a flat roof with approximate dimensions of 4.8m x 3.9m. Walls are built with 230mm thick unreinforced fire burned brick walls supporting the roof. The roof is constructed with ceramic tiles supported on steel beams, and a cement plaster coating is placed on top of the tiles. The foundation consists of unreinforced brick footings and foundation walls. The mud plastered floor is raised a minimum of 610mm above the surrounding ground surface. As designed, the shelter has one door and one window, along with air vents near the top of the walls.
