CASE STUDY **PHILIPPINES 2016–2018 / TYPHOON HAIYAN**

KEYWORDS: Shelter repairs, Structural assessment, Capacity-building, Cash and Technical Assistance

PROJECT SUMMARY

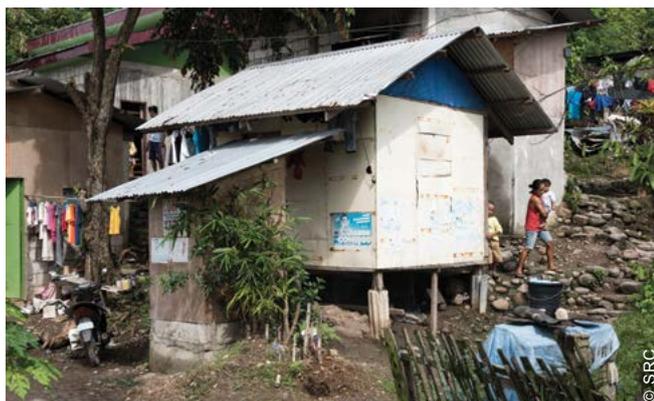
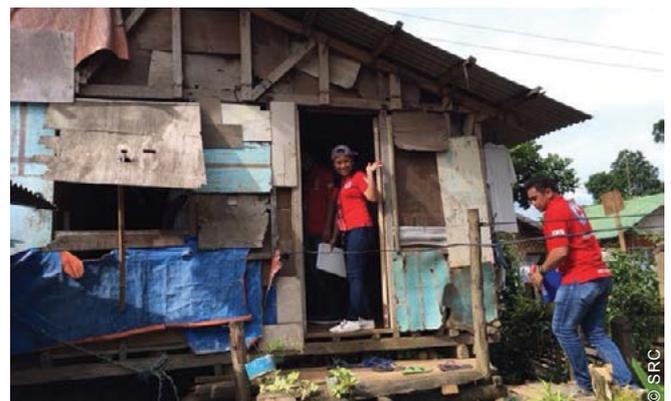
Many houses in the target areas were damaged to varying levels due to the typhoon. The project provided an option-based repair approach to upgrade all the key components of one core room of the house.

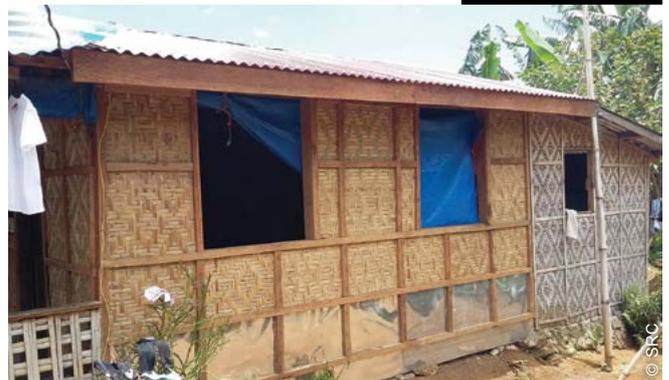
Cash was distributed in two tranches to achieve the repairs, following technical assessments of the quality of the works conducted.

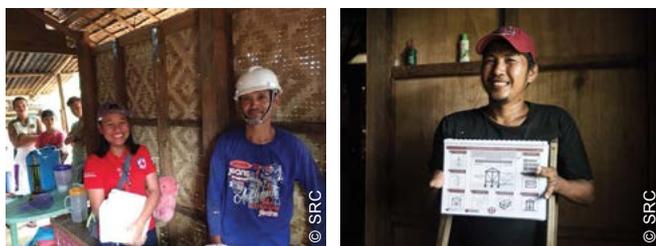
Technical support was provided to all households during construction, and on-the-job training given to project engineers.
