The following is an excerpt from the Book [Transitional Shelters: 8 Designs, IFRC, 2012](#), available from www.sheltercasestudies.org. [Inclusion of this design is for information purposes and does not necessarily imply best practice](#). Designs are site specific.

B.7 Indonesia, Aceh (2005) - Steel frame

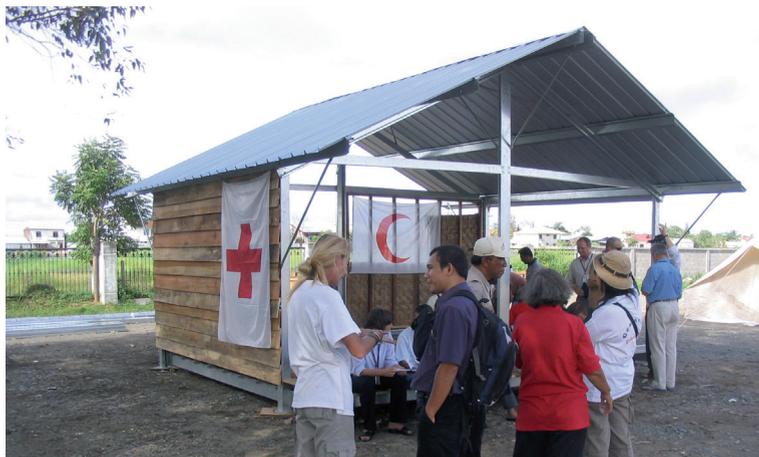
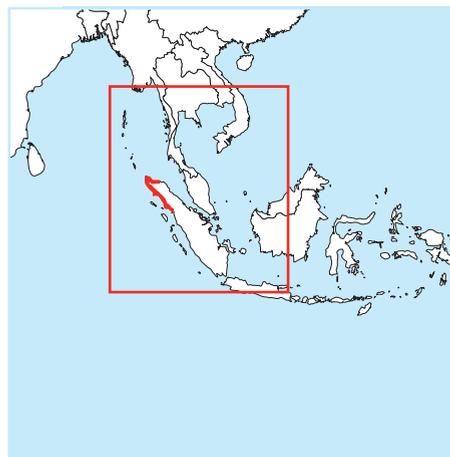
This shelter 'kit' presents a good design solution that is appropriate in areas vulnerable to high seismic loading although minor alterations are required for wind loads. Ensuring that timber planks are nailed to create a diaphragm or substituting them for plywood panels, strengthened columns and upgraded foundation details would improve its performance significantly (See Section C). It provides a transitional shelter option that is good quality, quickly scalable, and can be re-used or re-cycled. However it is comparatively expensive and there may be delays due to importation of materials. The design is similar to that of vernacular housing, with the steel replacing the traditionally used timber for the framing material.

The performance of the frame under gravity loads alone is adequate. The foundations must be upgraded to prevent the settlement of the column bases into the soil. Bracing is required in the walls and roof to improve the lateral stability and make the structure safe.

CHECK: In areas known to have high local wind pressures adequate foundations and member sizes must be provided.

CHANGE : Modify the foundations from base plate nailed to the soil to concrete pad foundation ([Section C.2](#)) depending on soil type to prevent settlement of shelter.

CHANGE: Use base plate or foundations or screw in ground anchor ([Section C.2](#)) to increase uplift and sliding resistance depending on soil type and wind loads.
