**B.3****Bangladesh - 2007 - Cyclone Sidr****Case study:****Core shelter, repair and awareness**

Full case study

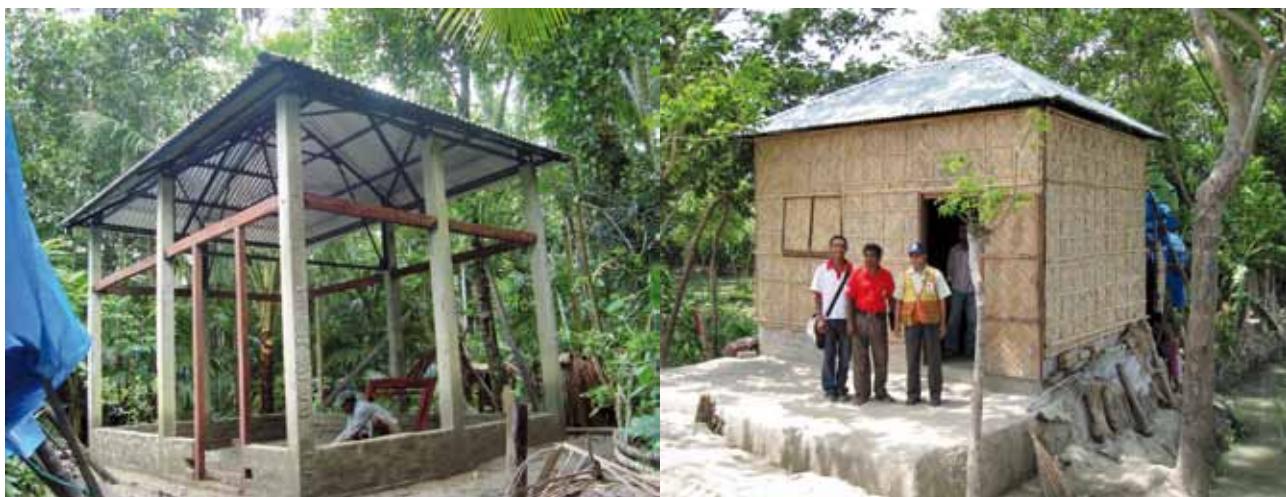
The core shelters were built by contractors and selection of families was through a lengthy transparent process  
 Left shows the frame of the structure  
 Photos: Xavier Génot, IFRC

The design of the core shelter was based on the wind-resistant shelter developed after the 1997 cyclone in the Chittagong area. As a result of limited land availability, the covered area was reduced to 15m<sup>2</sup>.

The core shelter was built on a mud plinth to protect from flooding. It was anchored to the soil by the 8 reinforced concrete columns with 5 feet deep foundations. The structure was braced, had a six-

The walls were made from woven bamboo mats. These were found to be cost-effective, environmentally friendly and allowed families to replace or repair them.

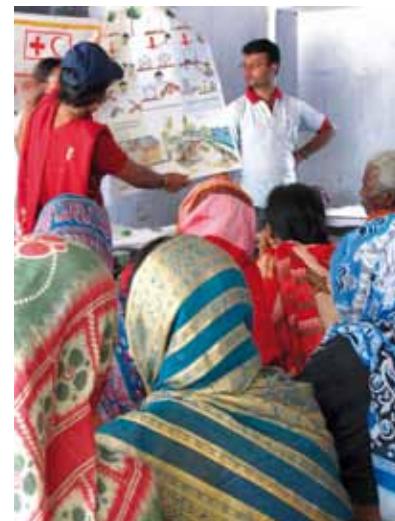
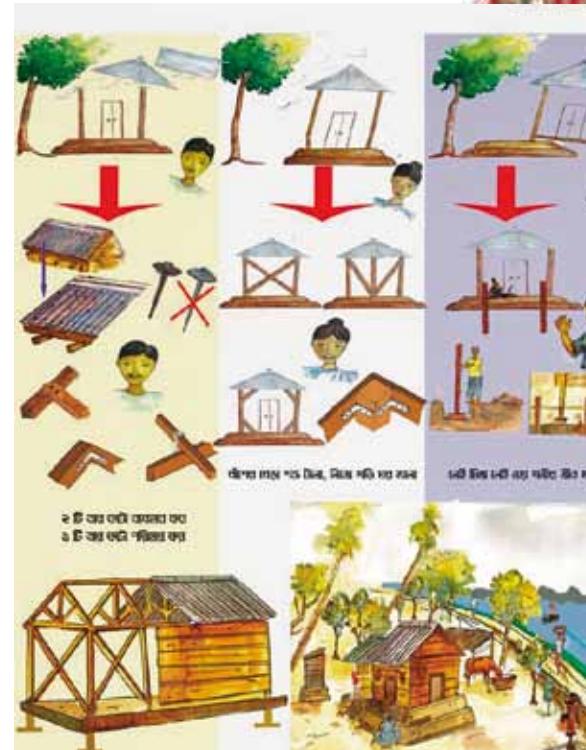
**Top:** training in safer shelter was a core component of the programme,  
**Below:** training poster developed for the Sidr Programmes  
 Photo: Xavier Génot, IFRC

Training events in safe shelter awareness were interactive and took about three hours. They were conducted in sessions attended by between 20 and 25 people, led by two people and monitored by one observer. Trainings were to help families to assess their shelter vulnerability, help families to strengthen their shelters (with focus on bracing, foundations and roofing), and to present toolkit components.

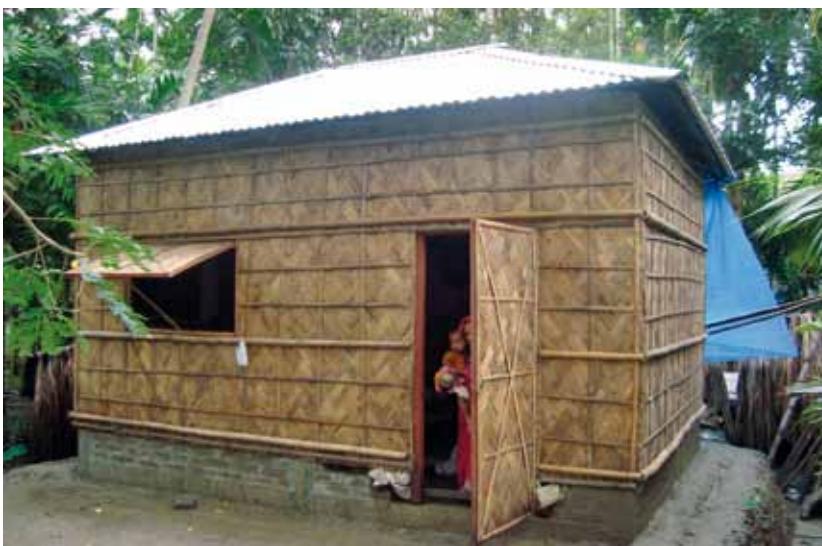
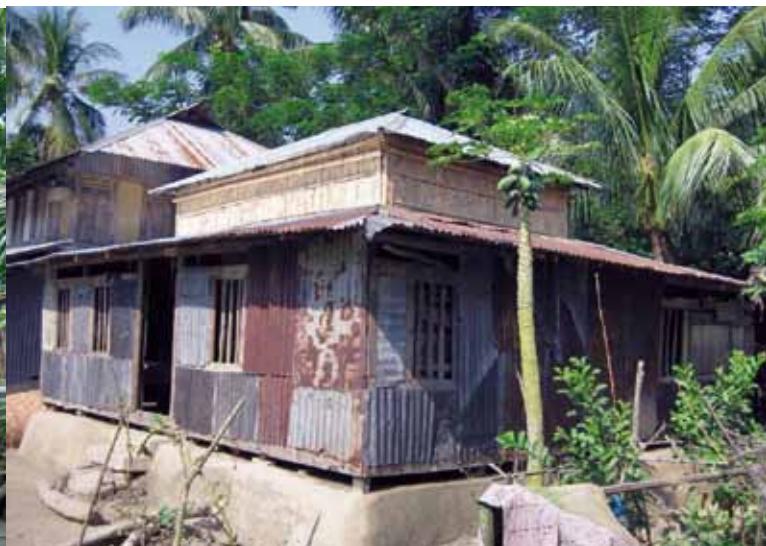
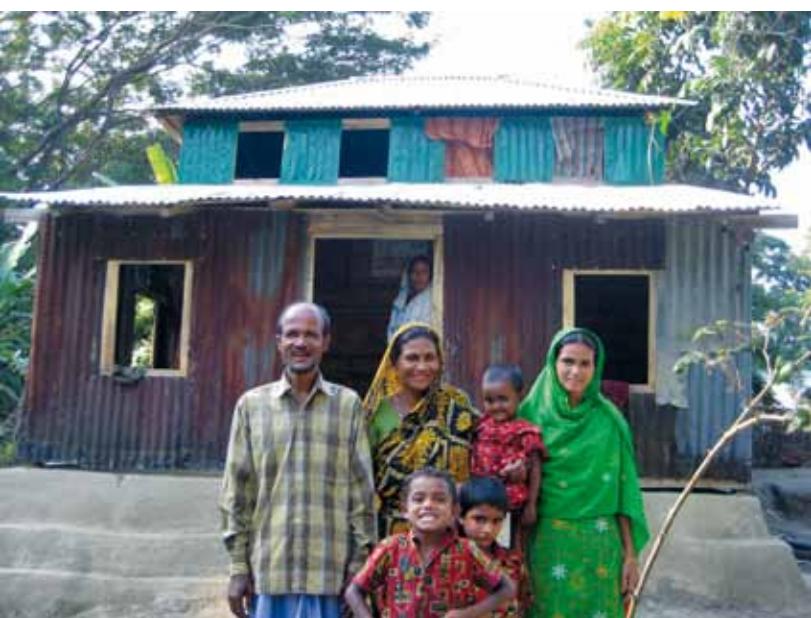
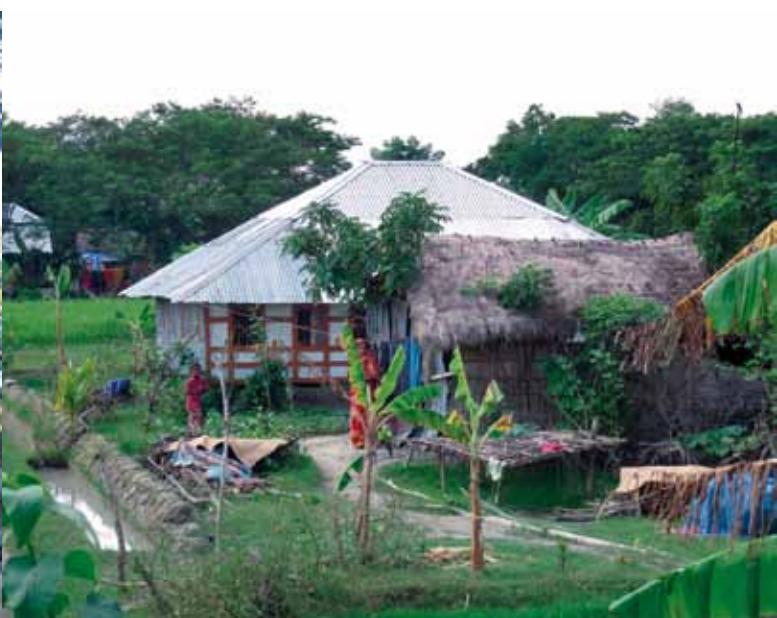
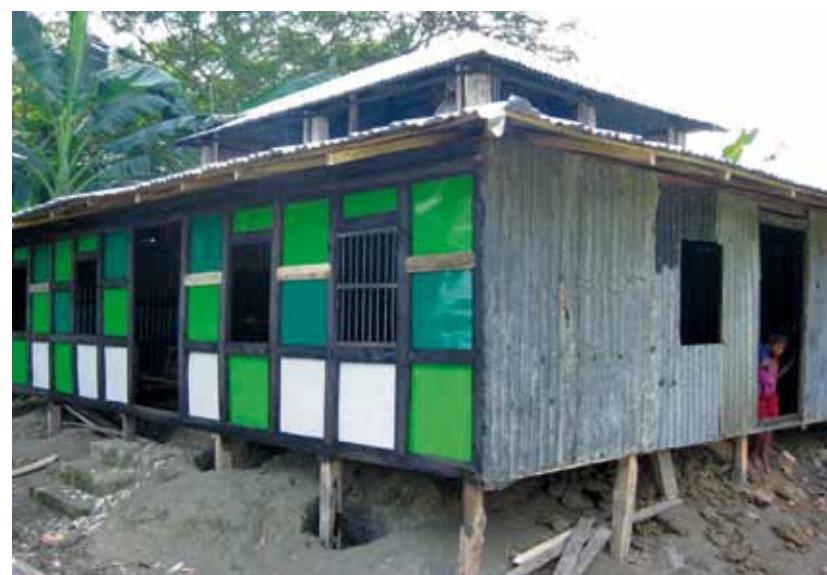
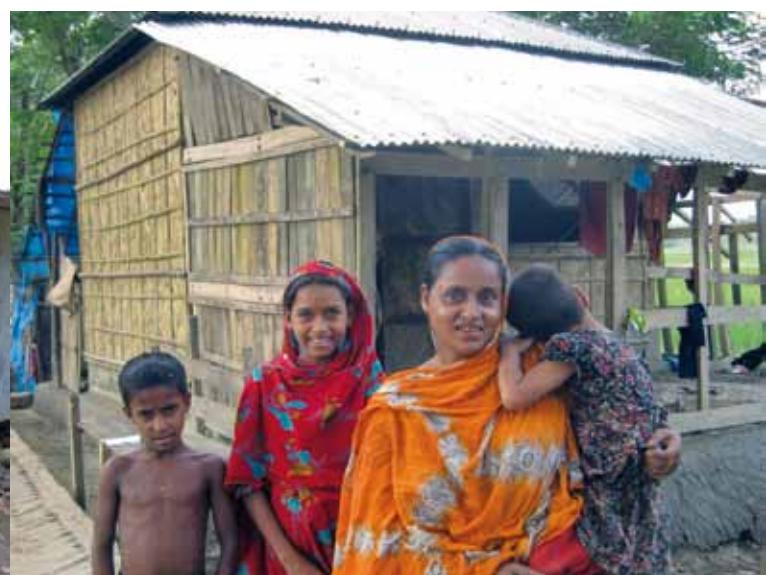
The programme provided support for families to upgrade their shelters. Many families were able to make improvements and extensions from the core house (top left) to the various extended structures (above)

and brackets could be found in the repairs and extensions that families had built.
