A.22 Philippines – 2012 – Typhoon Bopha

Case study

Emergency: Typhoon Bopha (Pablo), Philippines.

Project description:

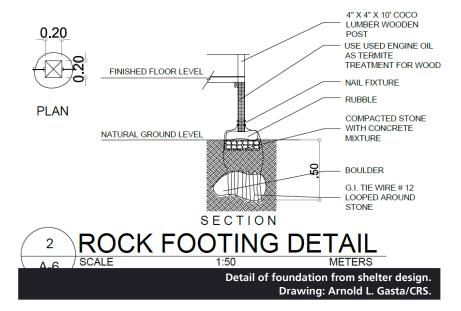
- Reinforcement of key structural joints: Connections between wooden pillars, beams, trusses, roof purlins, and bracing were reinforced with metal strapping.
- Lateral bracing: Cross- or cornerbracing was applied to increase the frame's resistance to lateral forces.
- Firm anchoring of roofing sheets: Sheets were held in place using fasteners such as J-hooks or bolts.
- Raised floor: Shelters were constructed above typical flood levels.
- Foundations: Frames were built upon, and anchored to, concrete or stone foundations buried 50cm-100cm below ground, to prevent both uplift during storms and subsidence.

The organisation trained local, skilled carpenters in how to implement the techniques and paid them to apply these techniques to the shelters.
