A.24 Philippines – 2013 – Typhoon Haiyan

Case study

Keywords: Household items; Construction materials; Transitional shelter / T-shelter; Training.

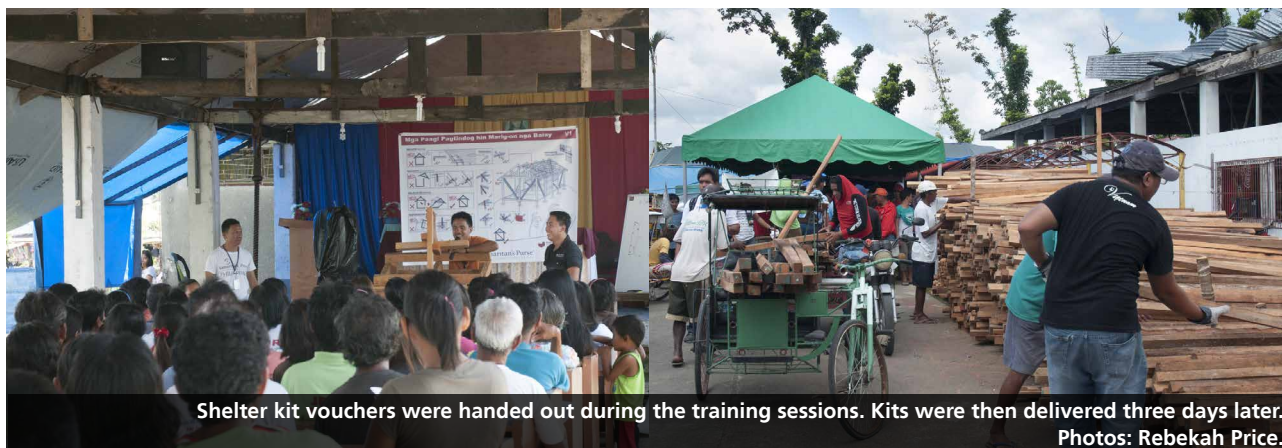
Shelter kit vouchers were handed out during the training sessions. Kits were then delivered three days later. Photos: Rebekah Price.

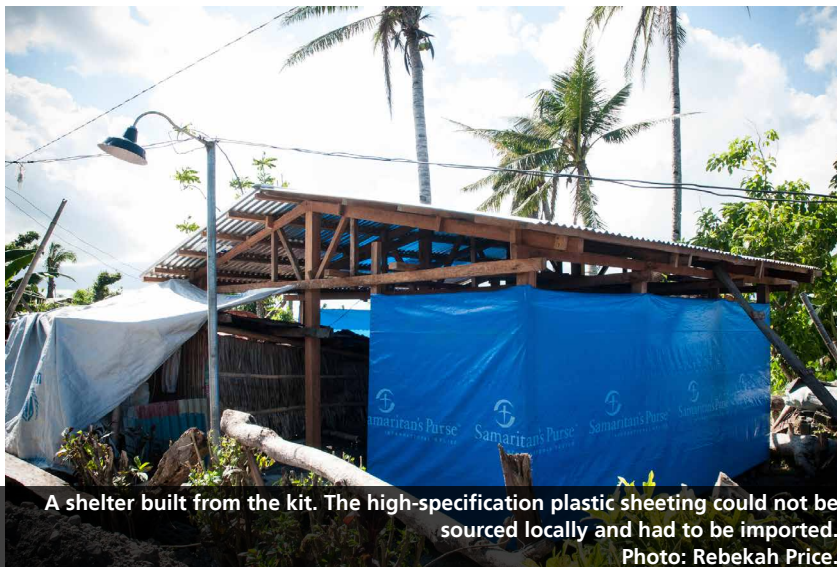
A shelter built from the kit. The high-specification plastic sheeting could not be sourced locally and had to be imported. Photo: Rebekah Price.

The shelter kits were designed to be flexible in order to meet beneficiary needs. Four different kits were designed in response to different levels of damage:

- Full Kit (3.65m x 4.88m)
– for families of more than three people.
- Small Kit (3.65m x 3.65m) - For families of three people or less.
- 70% Shelter Kit (for damaged houses).
