B.4 Indonesia - Aceh - 2004 - Tsunami and earthquake

Case study: Shelter or housing?

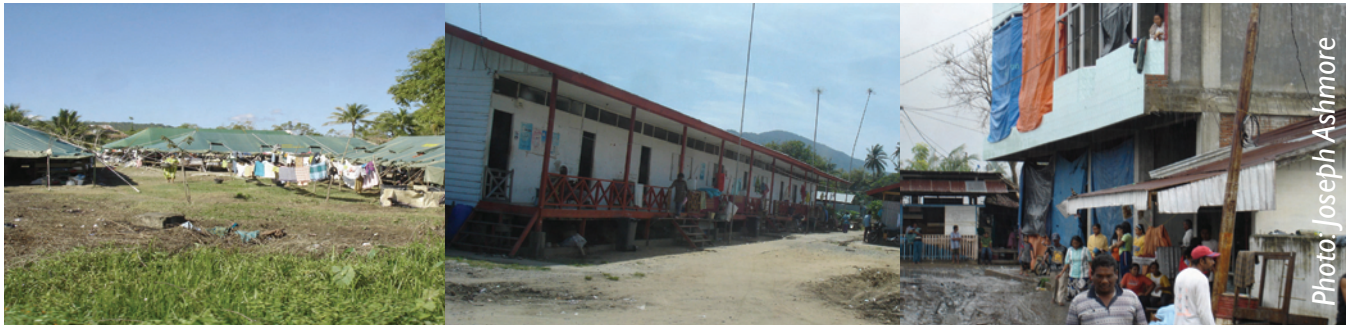
In the first weeks after the tsunami, people found shelter in large collective tents (left), squatted buildings (right), tents, rented housing or with friends and family. The government built transitional living centres (centre).
