A.25 Philippines – 2013 – Typhoon Haiyan

Case study

Emergency:	Typhoon Haiyan (Yolanda), Philippines.
Date:	8 th November 2013.
Damage:	1.12 million houses damaged.
People affected:	Approximately 14 million affected, 4.1 million displaced.
Project location:	Tanauan and Tacloban, Eastern Leyte.
Beneficiaries:	35,000 - 45,000 people.
Outputs:	6,615 shelters (3,277 completed as of September 2014).
Occupancy rate:	100%.
Shelter size:	Average of 12.5m ² depending on household inputs. Engineers make recommendations based upon <i>Sphere</i> .
Cost per shelter:	The organisation provides US\$ 450, with beneficiaries' self-recovery efforts valued at around US\$ 250.

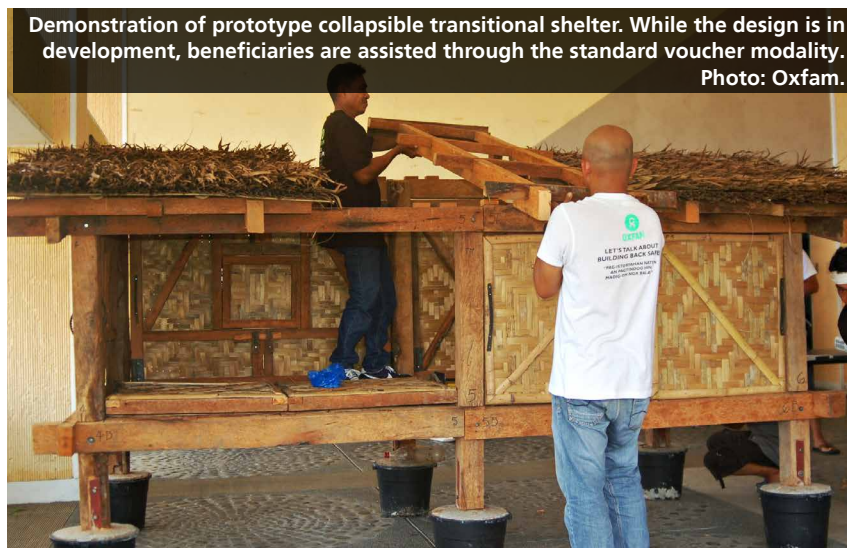
Demonstration of prototype collapsible transitional shelter. While the design is in development, beneficiaries are assisted through the standard voucher modality. Photo: Oxfam.

As part of the project, a prototype collapsible shelter has been developed and is currently being tested. In the meantime, the project's standard shelter response is being implemented in Tacloban.

To deal with the restrictions on rebuilding in the NBZ, the project engineering team designed the prototype shelter so that it would be easy to dismantle and re-locate. The design is extendable and can be upgraded if sited in a safe area.

The final collapsible shelter design can be dismantled in 2-3 hours, making it possible to completely collapse the shelter if there is advance warning of an extreme typhoon. The dismantling requires no skilled labour and the shelter itself is made from local materials.
